NORTH CAROLINA STATE HISTORIC PRESERVATION OFFICE
Office of Archives and History
Department of Cultural Resources

NATIONAL REGISTER OF HISTORIC PLACES

Bath School

Bath, Beaufort County, BF0471, Listed 1/30/2008
Nomination by April Montgomery
Photographs by April Montgomery, August 2006 and July 2007 (façade)

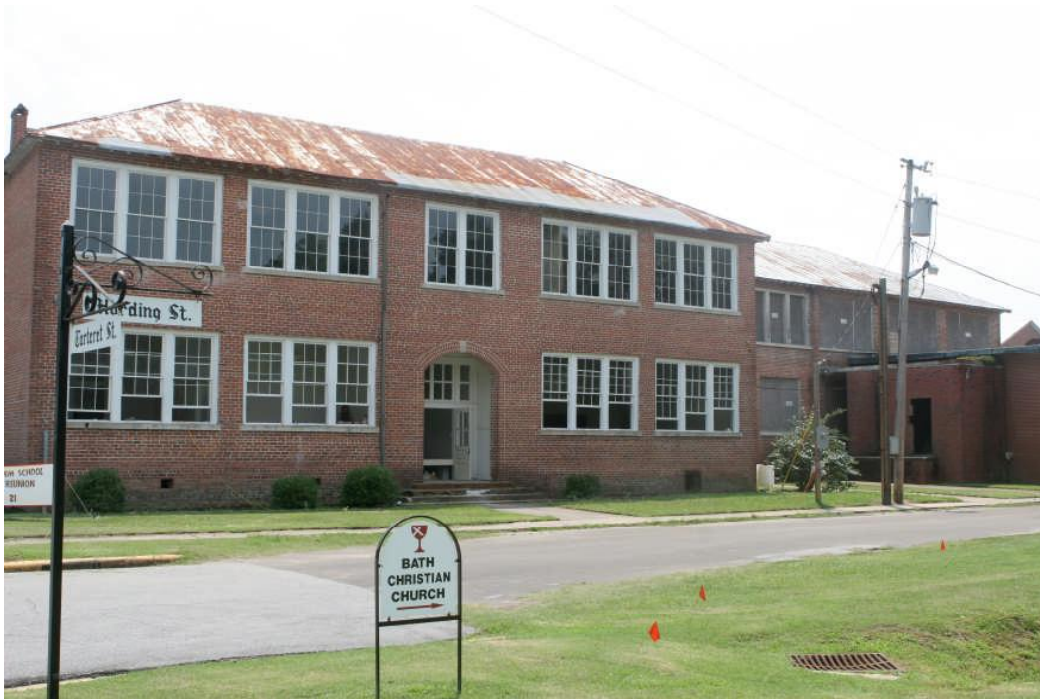
Façade view of 1920 building on left; 1918 building on right

The first building to be constructed on the site was the 1918 classroom building. This west-facing two-story, five-bay structure has a brick chimney piercing the roofline at its north end. Windows on the lower level of the building are paired six-over-six double-hung sash, while upper level windows are six-over-six double-hung sash in sets of three. The building was originally accessed at the ground level through a central solid door with a six-light transom. This entry is no longer present. The upper level was accessed by a frame exterior stair on the south elevation that led to a solid door with three-light transom. The frame stair was removed and a semi-enclosed brick stairwell with arched openings and cast stone keystones was constructed in its place ca. 1930.¹ Each stair configuration is visible in historical photographs of the school.

The 1920 classroom building was the second building constructed on the site. This west-facing five-bay structure has multiple brick chimneys piercing its roof-line. Windows on both levels are six-over-six double-hung sash in sets of three. The central entry bay on the lower level façade is inset under a brick arch with a keystone. The paired entry doors are half-glazed with multi-light sidelights and transom. Exterior stairwells with framed entries of brick arches and cast stone keystones access the upper level classrooms on the north and south elevations.

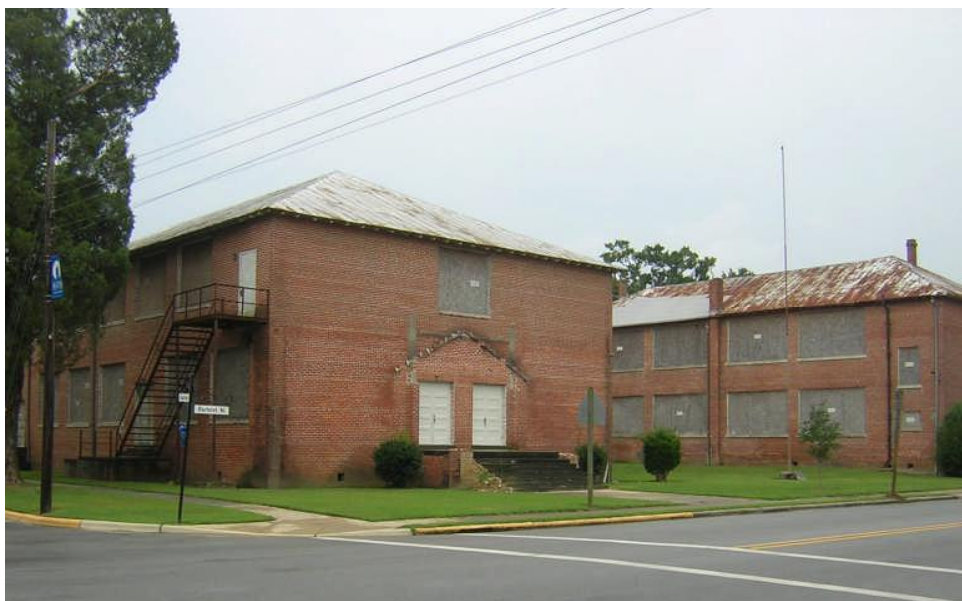
1921 Auditorium wing on left

The 1921 Auditorium Building was the final structure to be built during the initial school construction phase. The façade of this two-story structure faces north toward Carteret Street on the short end of the building. Small brick chimneys pierce the roofline. The entirety of the building's lower level houses the auditorium, which remains intact with stage, side rooms and original seats. Paired double-leaf entry doors access the auditorium from the Carteret Street façade while additional access to the auditorium is provided through double-leaf entries on the east and west elevations. Access to the upper level is provided by an exterior metal stair on the east elevation and the two-story hallway and enclosed stairwell off the south end of the west elevation. The upper level houses four classrooms, two on each side of a central hallway that bisects the building from north to south. A library and adjacent office span the building's south end. The hallway wraps around the east side classroom at the north end leading to a door to the exterior metal stair. At the south end, the hallway turns and leads to a two-story hyphen connecting the auditorium building to the 1918 and 1920 classroom buildings.
