**NATIONAL REGISTER OF HISTORIC PLACES**

**Samuel Bartley Holleman House**

New Hill vicinity, Wake County, WA1026, Listed 1/30/2008

Nomination by Cynthia de Miranda

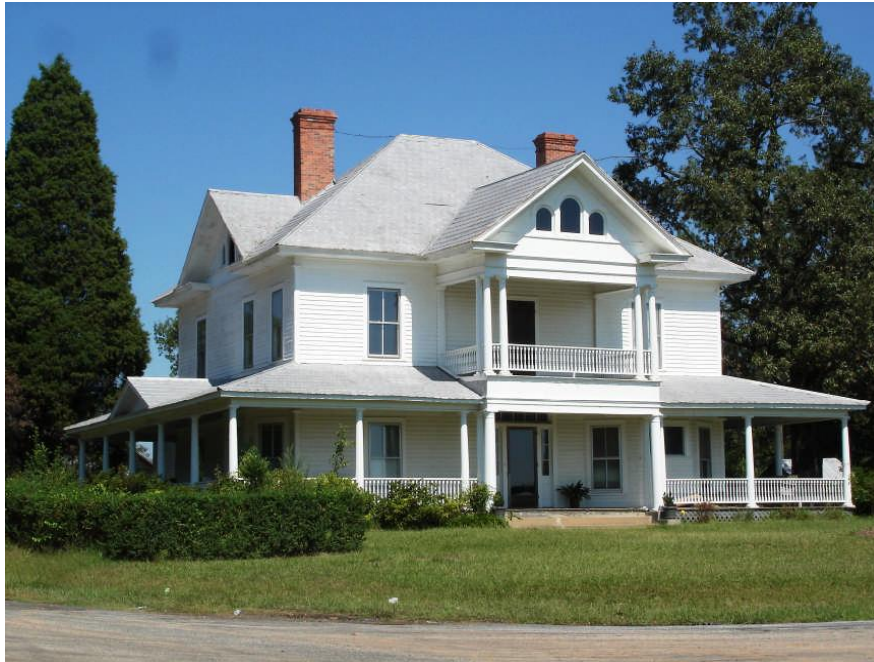
Front and side view

The south-facing facade of the Holleman House overlooks Avent Ferry Road and features three bays at each of its two full stories, including a three-sided bay window at the east end of the first floor. The center section of the bay holds a high, wide, fixed-sash window, while two-over-two double-hung sash fill its flanking sides. A transom and sidelights surround the single-leaf, five-panel glazed front door. The current owner, who purchased the house in 1991, added stained glass to the transom, sidelights, and the front door, but the original glass remains and the stained glass can be removed without damage to original architectural fabric. A wood-framed glazed storm door has also been added. The house features substantial cornerboards at each floor topped by projecting cyma reversa molding.

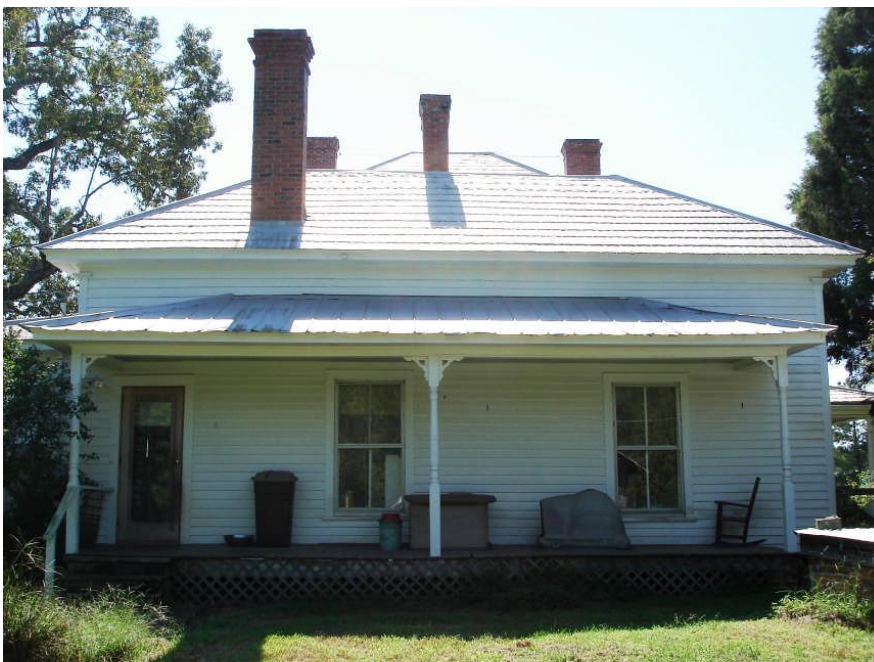
Rear view of kitchen wing

An examination of the floor plan and architectural features of the kitchen suggests another possibility: that the present-day kitchen was an earlier, detached kitchen. The fireplace has been enclosed by sheetrock but is evidently substantial in size, as one would expect for cooking. The original stack was apparently replaced with a corbelled brick version in the 1913 construction. The room features six doorways with a variety of doors, including historic four-panel doors, and trim. The room's windows have either two-over-two or six-over-six sash. The variety of door, trim, and window types may indicate the recycling of an outbuilding as an addition.
