Cliffside Steam Station Ash Basin

Topographic Map and Discharge Assessment Plan

NPDES Permit NC0005088

April 29, 2016

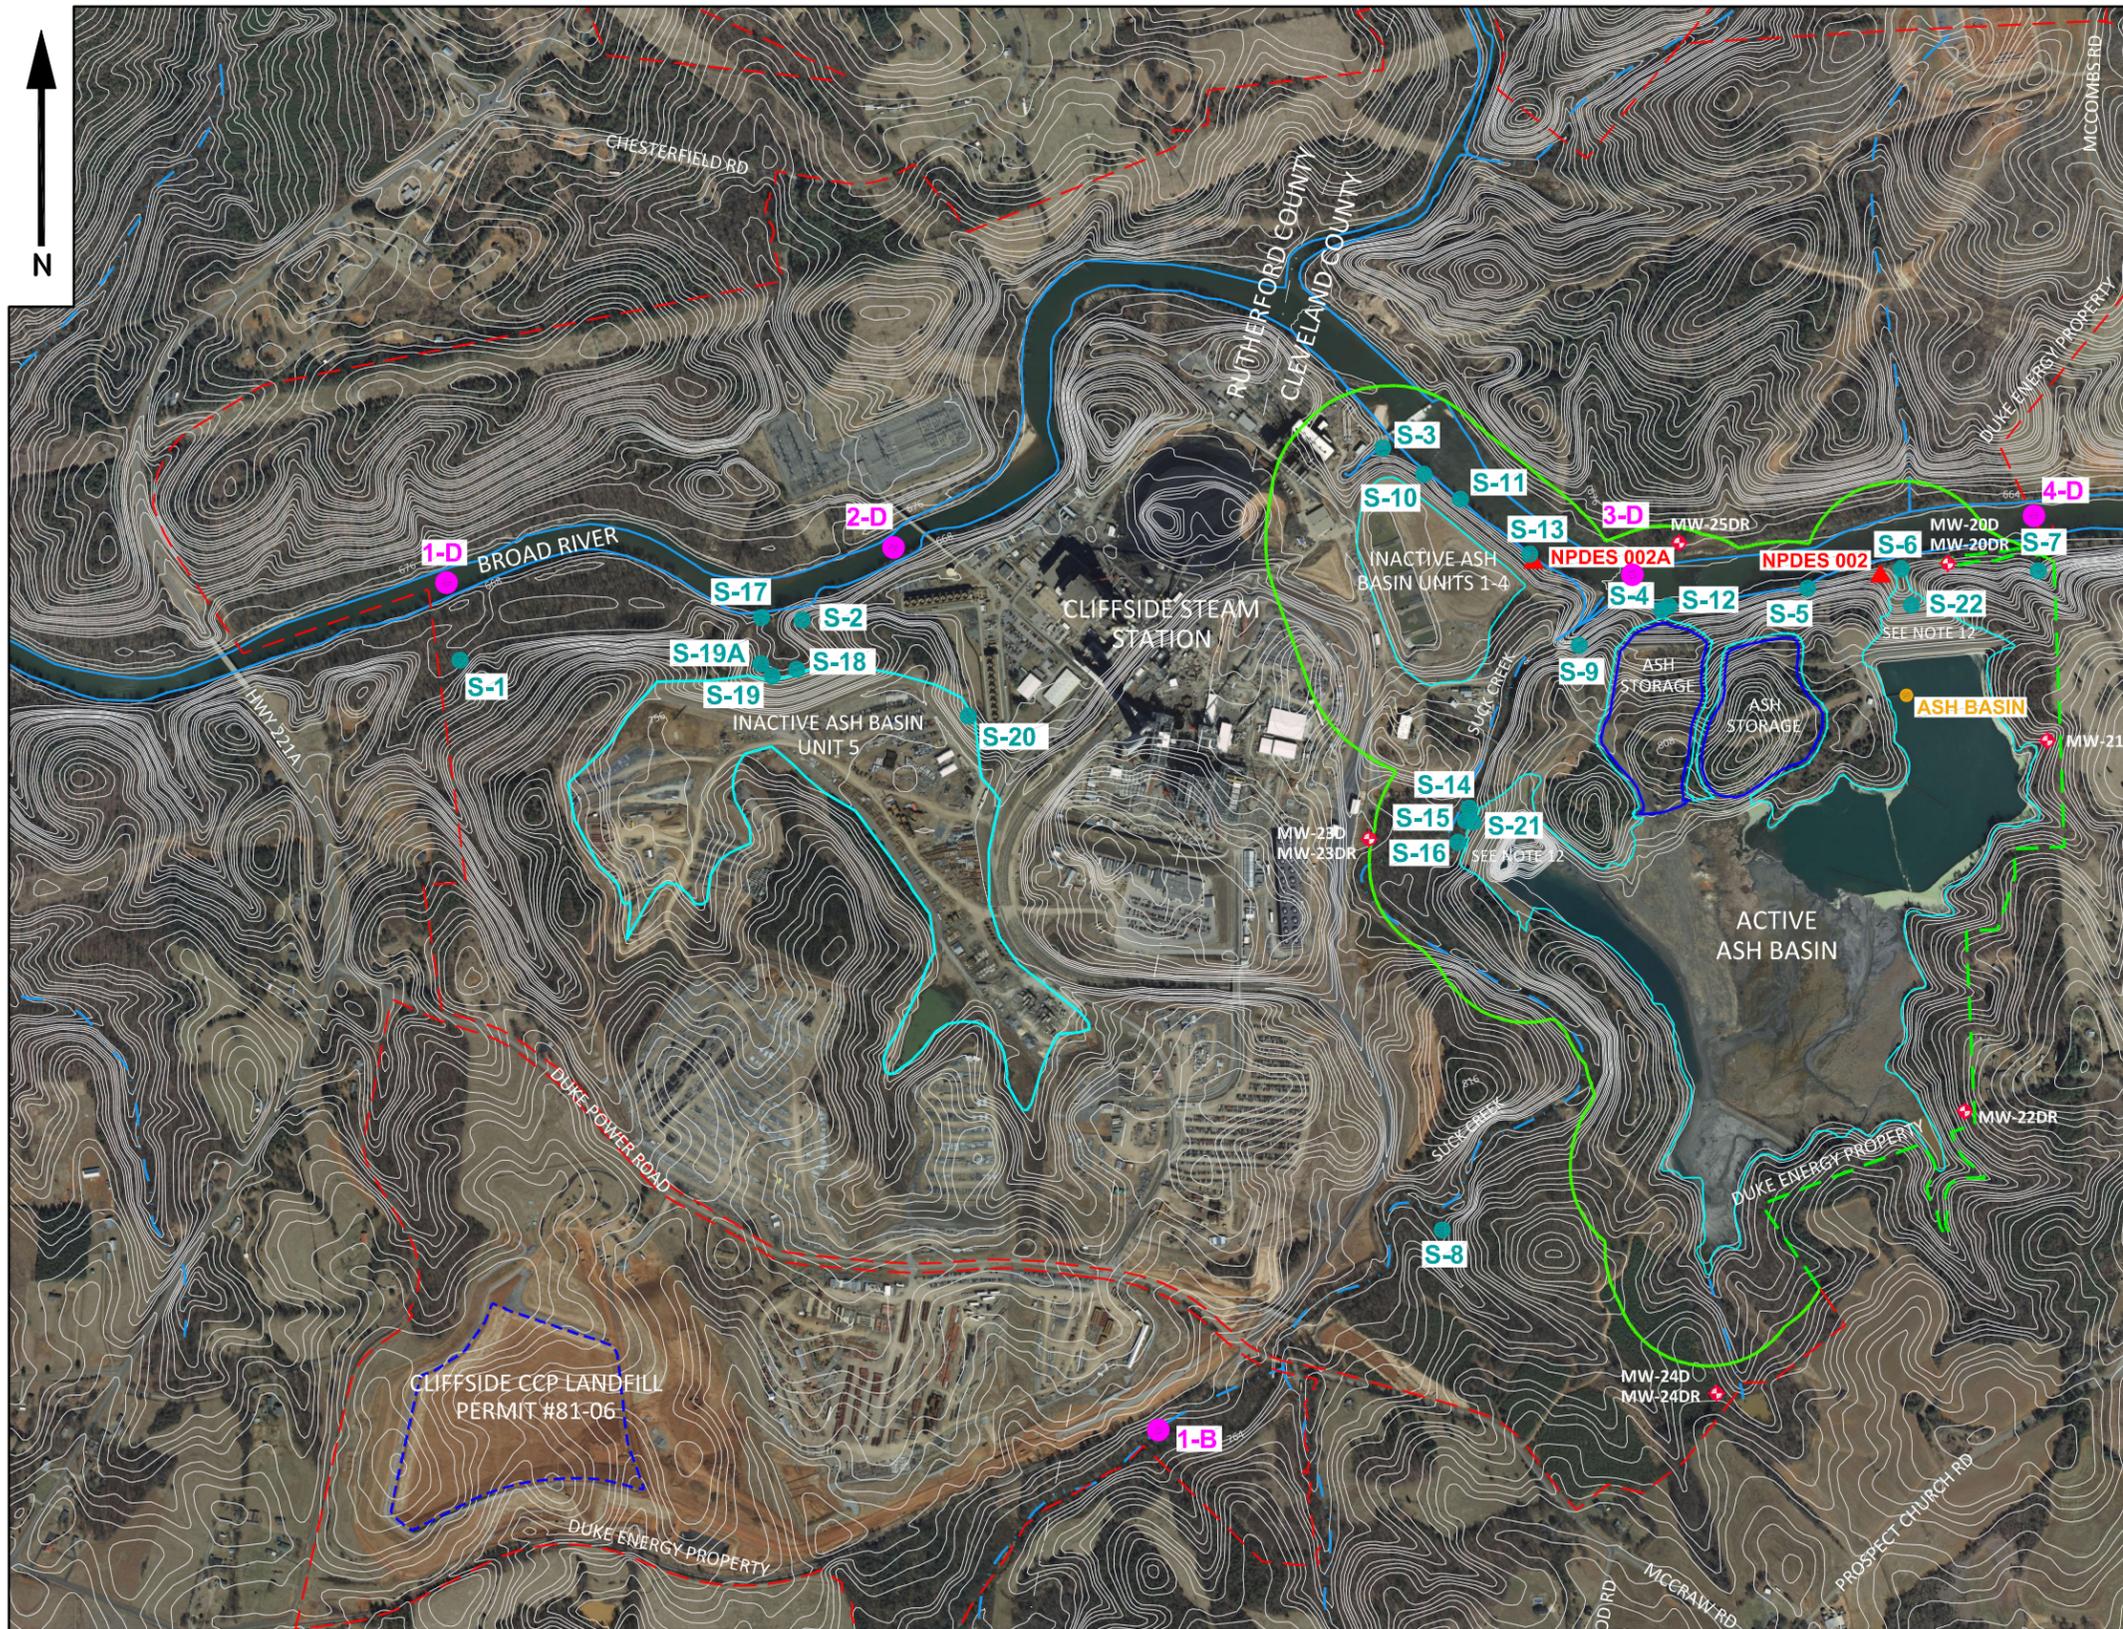
DATE
 DECEMBER, 2014
 FIGURE
 2

Seep / Discharge ID	Location Coordinates (NAD 83)		Flow Description	Flow Measurement (MGD) and Method	Background Location	Discharge Location and Discharge Sampling Location		Discharge Location Coordinates (NAD 83)	
	Latitude	Longitude				Latitude	Longitude		
S-1	35.216	-81.775	Continuous	0.0646 area-velocity		Northwest of the Inactive Unit 5 ash basin; tributary of Broad River 1-D	35.218	-81.775	
S-2	35.217	-81.768	Continuous	0.2004 area-velocity		Downriver from Inactive Unit 5 ash basin discharge canal 2-D	35.218	-81.767	
S-3	35.220	-81.758	Continuous	0.0882 area-velocity		At discharge canal for Units 1-4; tributary of Broad River 3-D	35.218	-81.753	
S-4	35.218	-81.753	Continuous	0.0129 area-velocity		North of the ash storage area; below outfall of concrete ditch 4-D			
S-5	35.218	-81.750	Continuous	0.0014 times-volumetric		North of the ash storage area; below outfall of concrete ditch 4-D	35.219	-81.746

S-6	35.218	-81.748	Continuous	0.0323 area-velocity		Downgradient of the active ash basin dike; tributary of Broad River 4-D			
S-7	35.218	-81.746	Continuous	0.0078 times-volumetric		Northeast of the active ash basin; northeast corner of property 4-D			
S-8	35.208	-81.756	Continuous	<0.0129 times-volumetric		Tributary to Suck Creek 3-D			
S-9	35.217	-81.754	Continuous	0.0013 times-volumetric		East side of Suck Creek; downstream of bridge 3-D			
S-10	35.220	-81.757	Continuous	0.0004 times-volumetric		Below inactive Units 1-4 south bank of Broad River 3-D	35.218	-81.753	
S-11	35.219	-81.756	Continuous	0.0025 times-volumetric		Below inactive Units 1-4 south bank of Broad River 3-D			
S-12	35.217	-81.752	Continuous	0.0003 times-volumetric		Below ash storage basin; south bank of Broad River 4-D	35.219	-81.746	
S-13	35.218	-81.75	No Flow	N/A		Along Units 1-4 dike 3-D			
S-14	35.214	-81.756	No Flow	N/A		Along active ash basin dike 3-D	35.218	-81.753

S-15	35.214	-81.756	No Flow	N/A		Along active ash basin dike 3-D			
S-16	35.214	-81.756	No Flow	N/A		Along active ash basin dike 3-D			
S-17	35.217	-81.769	Continuous	0.0017 times-volumetric		Along active ash basin dike; seepage from Unit 5 2-D			
S-18	35.216	-81.768	Continuous	0.0046 times-volumetric		Seepage from riprap at toe of Unit 5 2-D			
S-19	35.216	-81.768	Continuous	0.0009 times-volumetric		Seepage from wooded area at toe of Unit 5 2-D	35.218	-81.767	
S19a	35.216	-81.769	Continuous	0.0005 times-volumetric		Seepage from wooded area at toe of Unit 5 2-D			
S-20	35.215	-81.765	No Flow	N/A		Seepage at toe of Unit 5 2-D			
S-21	35.214	-81.755	No Flow	N/A		Engineered drainage at Suck Creek dam at active ash basin 3-D	35.218	-81.753	
S-22	35.217	-81.749	Continuous			Engineered drainage downstream dam at active ash basin 3-D

A topographic map is presented in Figure 2 to meet the requirements of GS 130A-309.210(a) in the identification of outfalls from engineered channels, as well as seeps and weeps.

Locations of seepage at the ground surface adjacent to the ash basin have been identified and are shown in Figure 2. These areas include the earthen embankments which impound the ash basin as well as adjacent areas where water from the ash basin may have infiltrated into the underlying residual materials and expressed as seepage.

The Cliffside active ash basin downstream dam and upstream dam were constructed with a zoned trench drain, a zoned blanket drain, and a zoned toe drain. The drainage features, or outfalls, associated with the ash basin dam are shown as required by GS 130A-309.210(a)(2)(i) on Figure 2.

Topographic maps of the site were reviewed to identify regions of the site where there was a potential for ash-basin-related seepage to be present. These regions were determined by comparing ash basin full pond elevations to adjacent topography with ground surface elevations lower than the ash basin full pond elevation. HDR staff performed site observations within these identified areas as part of NPDES inspections during the reapplication process during June, July, September, and November 2014 and documented locations where seepage was apparent at the time of the site visit. These seeps are identified as required by GS 130A-309.210(a)(2)(ii) on Figure 2.

Figure 2 and Table 1 present the background and downstream sampling locations to be considered as part of this Discharge Assessment Plan (DAP). These locations may be assessed by comparing surface water sampling analytical results of the associated background location with the corresponding downstream location. For discharges located at the toe of a dam, an upstream location within the channel may not have been possible to isolate for comparison given the proximity to the ash basin, which would have the same chemical composition as the discharge itself. As such, the upstream location was established upstream of the ash basin and is considered “background.” For discharges located a distance from the ash basin, an identified upstream or “background” location for sampling may be compared to the downstream portion of the discharge channel. The background and downstream sampling locations are shown on Figure 2 with “B” and “D” identifiers, respectively, and the corresponding seep locations associated with the sampling locations are indicated on Table 1.
