As-built report for the AH&W Mitigation Site Big and Little Warrior Creeks Wilkes County

As-built report for the AH&W
Mitigation Site, Big and Little Warrior
Creeks, Wilkes County

North Carolina Wildlife Resources Commission

February 24, 2003

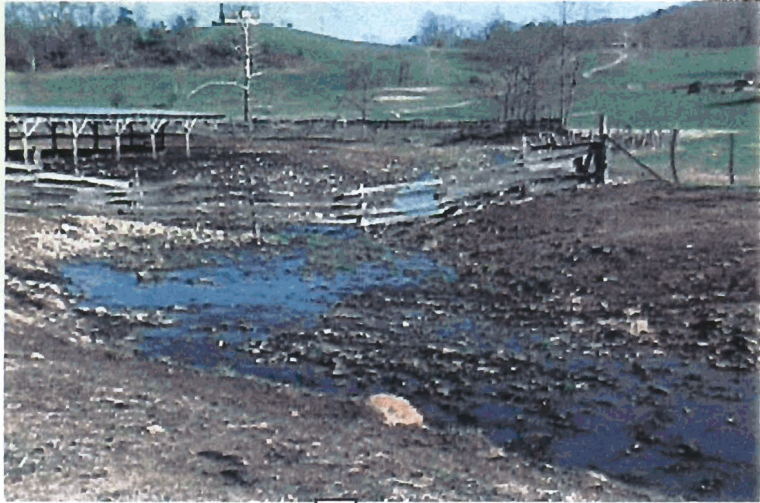
Big Warrior Creek before construction, 12/9/98

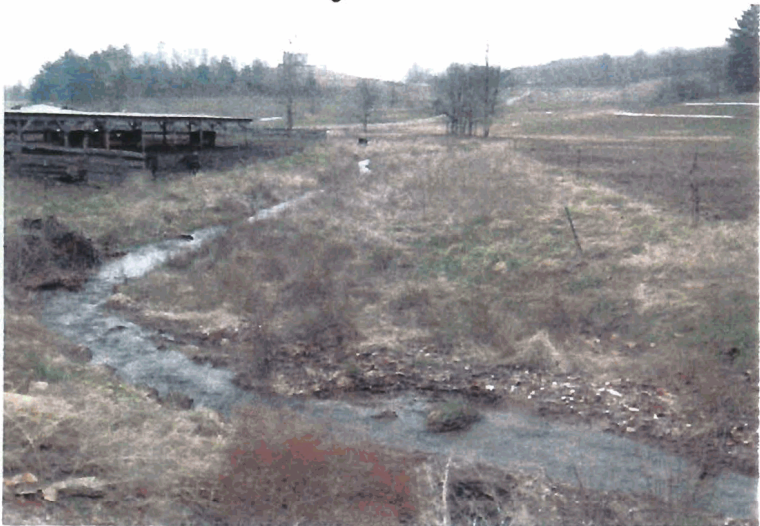
Big Warrior Creek after construction, 1/30/03

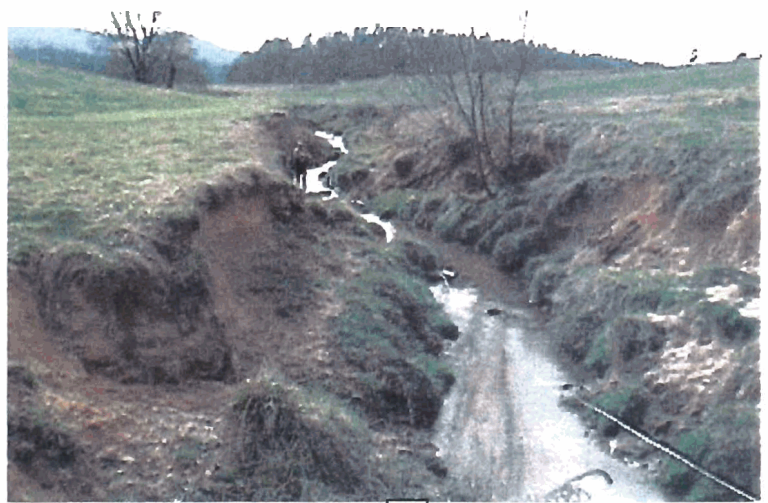
Little Warrior Creek before construction, 12/11/98

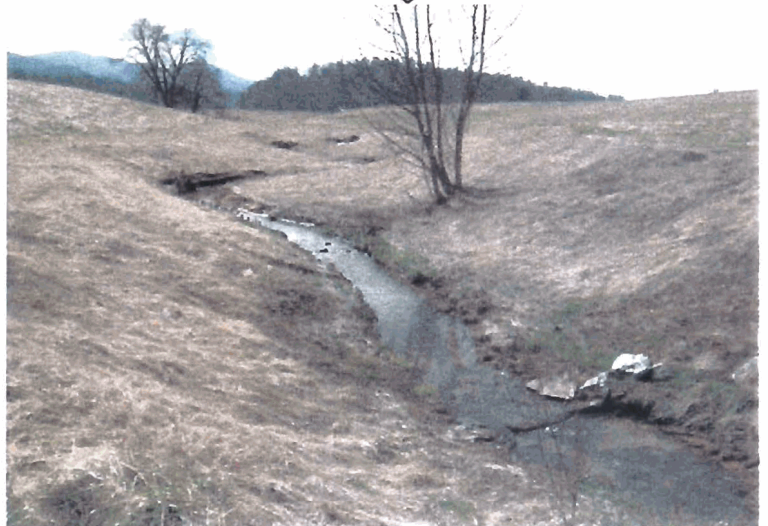
Little Warrior Creek after construction, 1/30/03

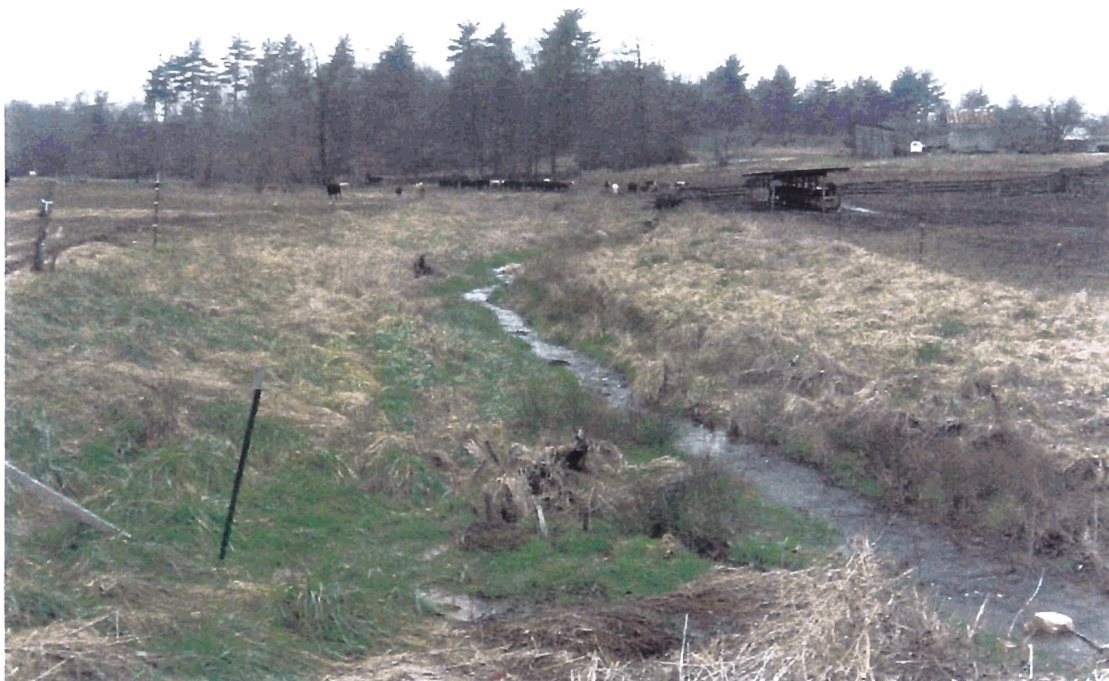
DSC00266, 3/1/30

Reach is in the middle of the feedlot, on Big Warrior Creek. Photo is taken from the right bank, just below survey point 1A44, looking upstream. This is series number 27 from the BWC reference photos.

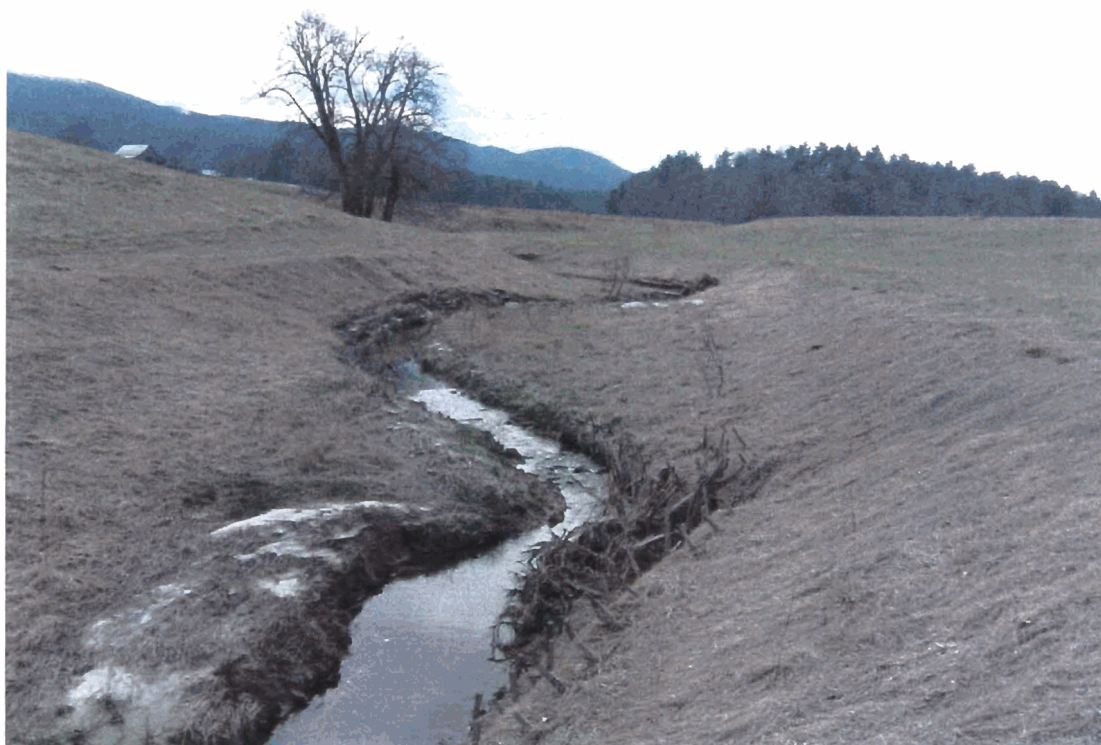
DSC00320, 03/1/31

Reach is **the** lower end of the lower pasture, on Little Warrior Creek. Photos are taken from just upstream of survey point 2A38 looking upstream
This is series number 4 from the LWC reference photos.
