# ***YEAR 2 MONITORING REPORT***

## **ADKIN BRANCH STREAM RESTORATION PROJECT PHASE 1 – WASHINGTON AVE. TO LINCOLN ST.**

Lenoir County, North Carolina  
EEP IMS No. 7

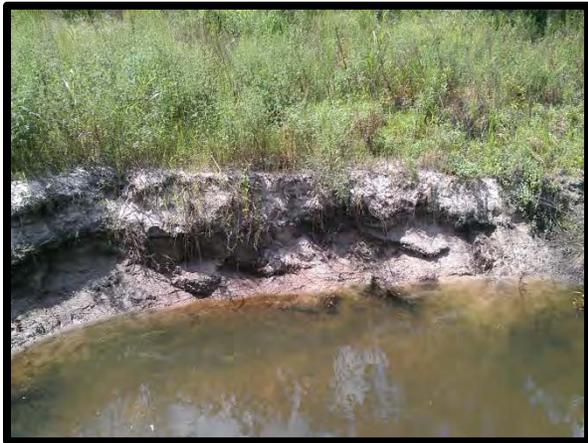
**3.21 Severe bank erosion near 65+35**

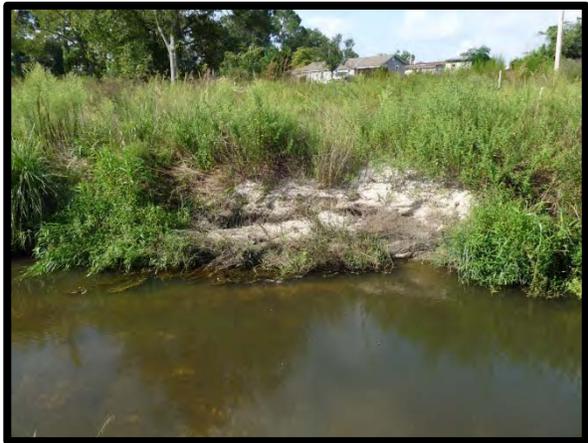
**3.22 Severe erosion downstream of pedestrian bridge (84+30).**

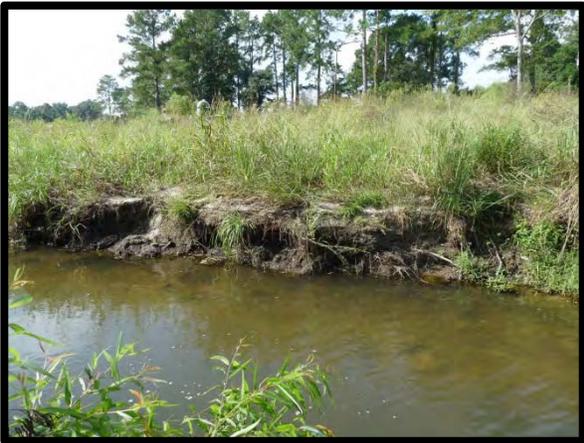
**3.23 Severe erosion upstream of pedestrian bridge (83+50)**

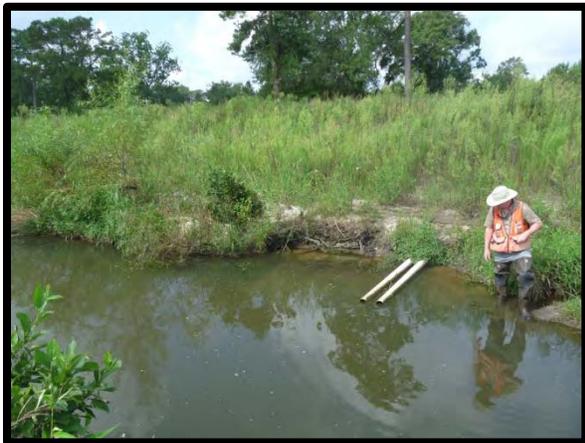
**3.24 Severe erosion near 86+70**

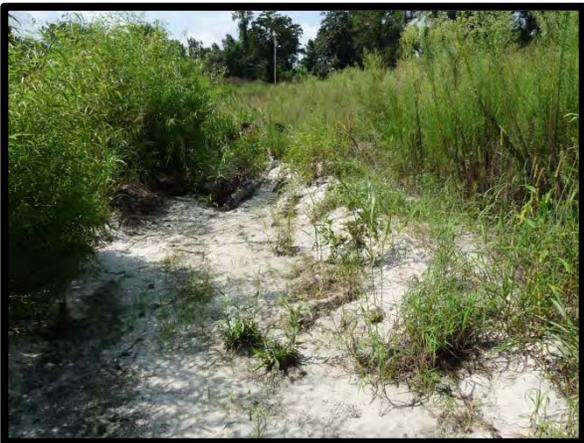
**3.25 Severe erosion near 92+50**

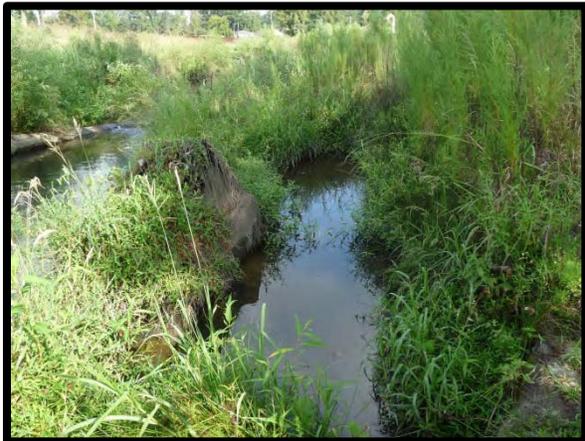
**3.29 Severe erosion around vane arm  
2011 (87+50)**
