YEAR 3 MONITORING REPORT

ADKIN BRANCH STREAM RESTORATION PROJECT PHASE 1 – WASHINGTON AVE. TO LINCOLN ST.

Lenoir County, North Carolina
EEP IMS No. 7

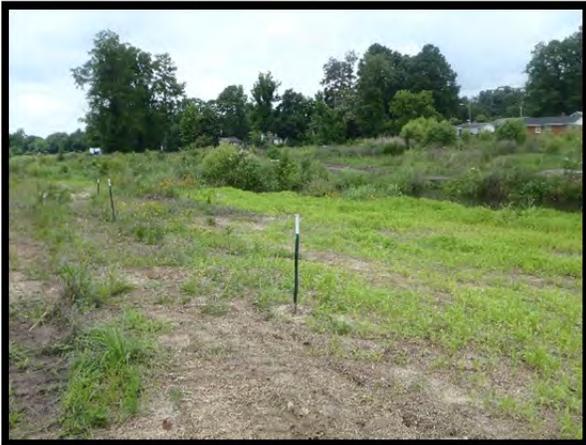
3.9 Vegetation Plot 9

Fifteen of the twenty-two individual vegetation plots met success criteria when counting planted stems alone. Plot 9 was not sampled because it was destroyed by construction equipment during stream repair efforts in July 2013. The site is scheduled to receive supplemental planting in areas disturbed by the construction activities of 2013. The areas that are to be replanted include the staging and stockpile locations, haul road and any other area within the easement that were impacted by construction equipment. Three plots (Plots 6, 10, and 11) did not meet success criteria based on planted stems alone; however, when including appropriate naturally recruited stems of hickory (*Carya* sp.) and American elm (*Ulmus americana*), these plots exceeded success criteria. Herbaceous vegetation has continued to fill in stream bench areas that were bare in Year 1 (2011). Planted tree growth within the Site, in general, is poor. These issues encompass the majority of the Site and should be monitored closely in subsequent monitoring years. Several small areas of invasive species occur within the Site including Chinese privet, Johnson grass, lespedeza, and Japanese honeysuckle as depicted on the CCPV (Appendix B).

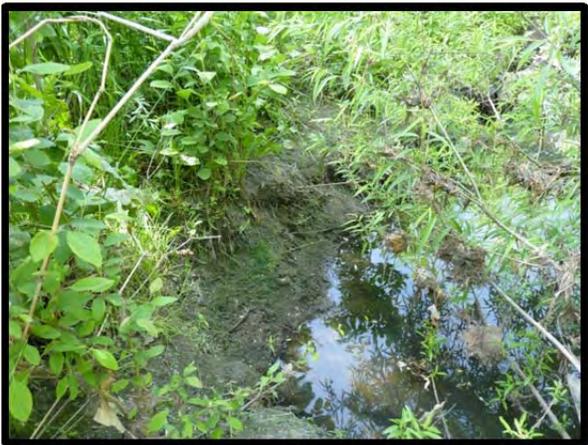
3.21 Minor erosion near 45+00

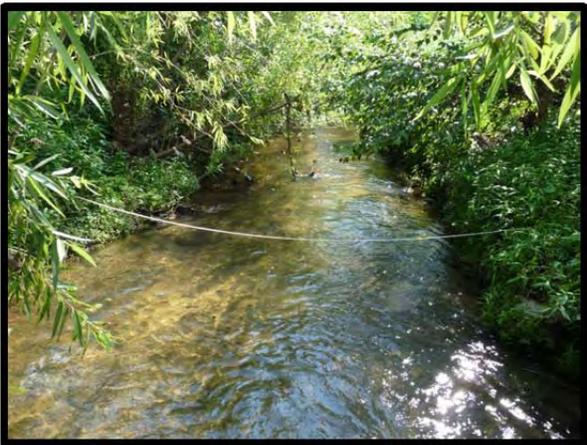
3.22 Thin grass/bare on right bank of cross section 5

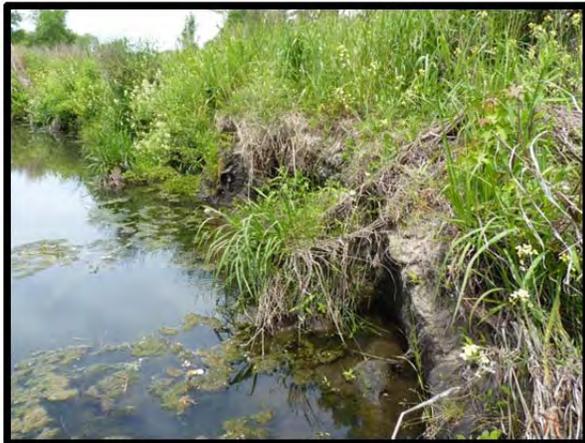
3.23 Severe erosion near cross section 10

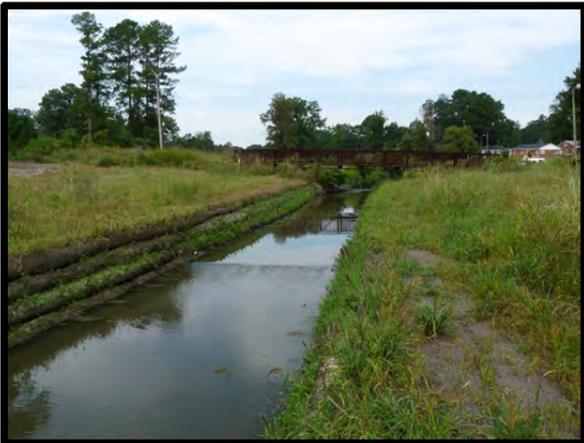
3.24 Additional soil lifts
