**YEAR 5 of 5 Monitoring Report  
Tributaries of Wicker Branch Stream Restoration  
Union County, North Carolina  
DMS Project Number: 95022  
Contract No: 003982  
USACE Action Id No: SAW 2013-01680**

**YEAR 5 of 5 Monitoring Report**  
**Tributaries of Wicker Branch Stream Restoration**  
**Union County, North Carolina**  
**DMS Project Number: 95022**  
**Contract No: 003982**  
**USACE Action Id No: SAW 2013-01680**

**RE: Year 5 (2019) Monitoring Report the Tributaries of Wicker Branch Project (DMS Project # 95022)**

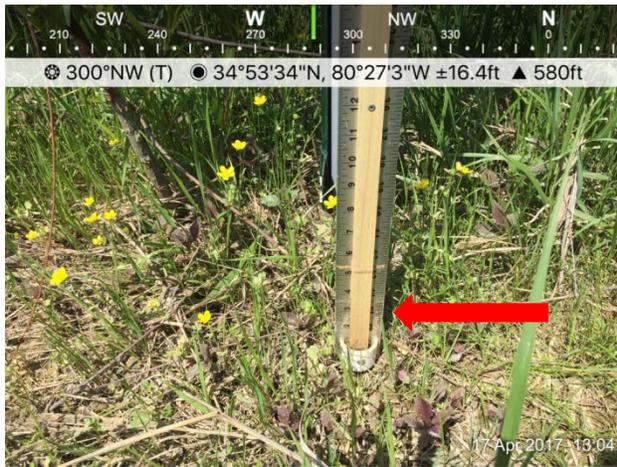
Photo of wrack lines from 11/23/2014 bankfull event

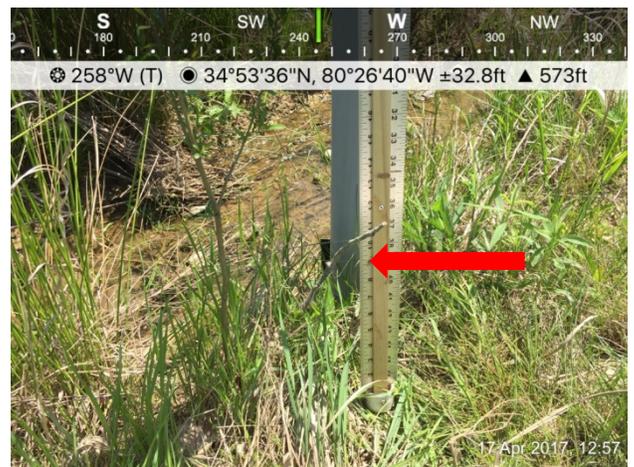
Tributary 1 Crest Gauge 4/17/2017

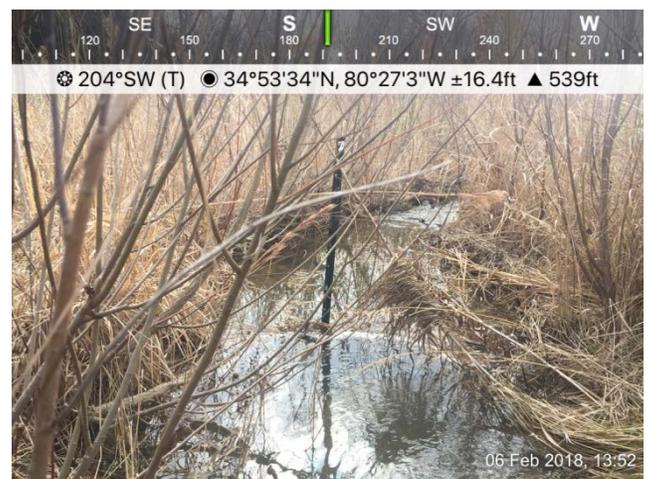
Tributary 1 wrack lines 2/6/2018

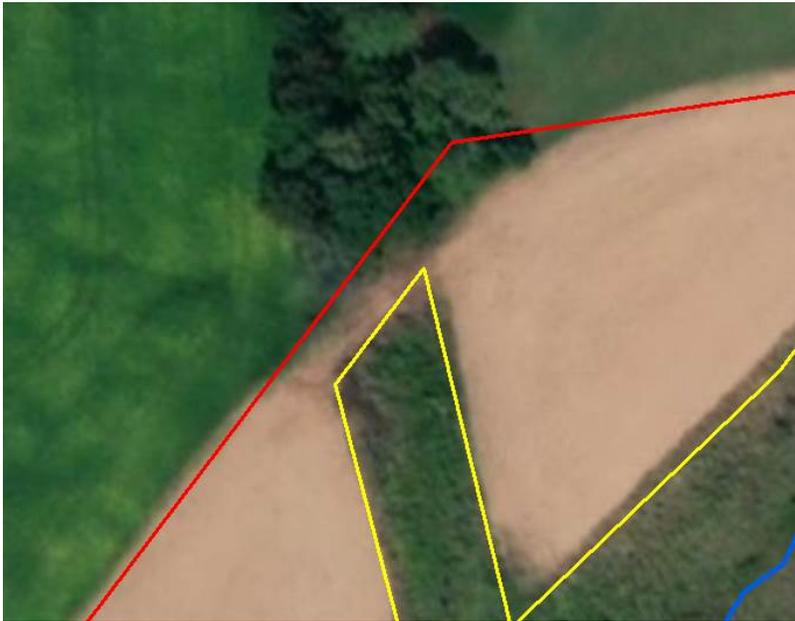
There has been some clipping at the northeast corner of Tributary 1A. This has been due to lack of adequate signage and the farmer not knowing/aware of where the corner was. AECOM had difficulty installing adequate signage in this area due to the hardness of ground. A wooden post was installed in this area in the Fall of 2018 and should eliminate the encroachment. The post will be “updated” with

a taller post this winter/spring when other boundary markers are upgraded.

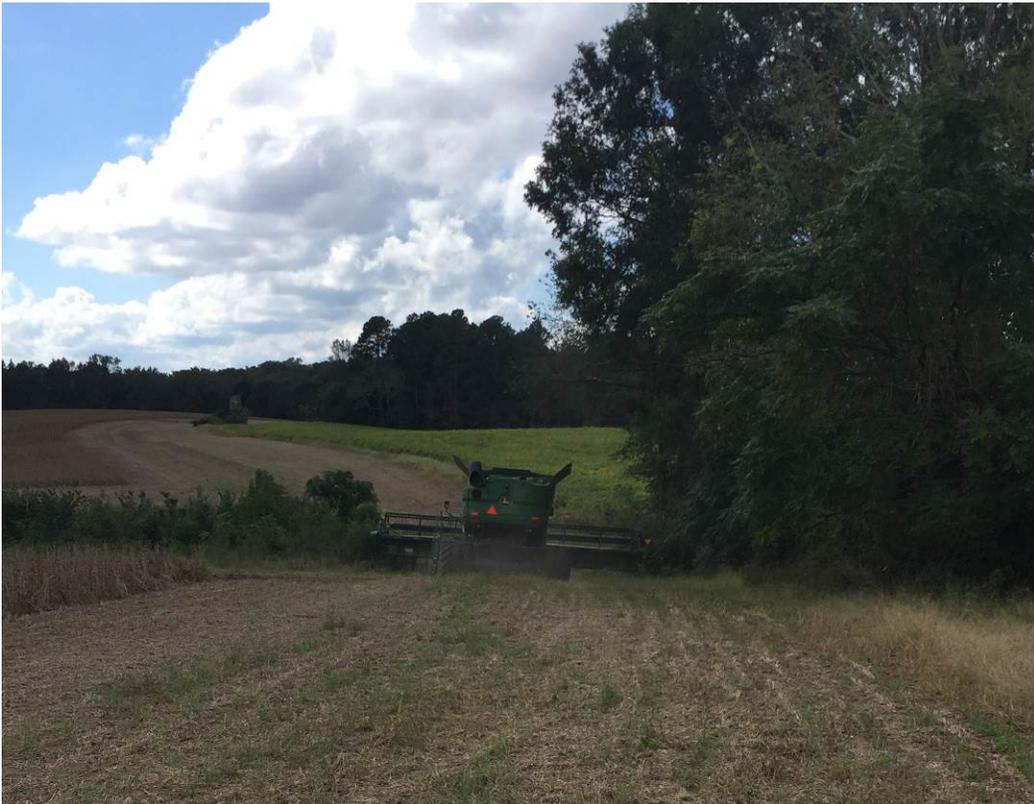
The above photo depicts the location of the corner of the easement at the top of Tributary 2 in relation to the treeline. The Yellow Line is the far (northeast) corner of the easement and the wood post with the sign is the northwest corner. There is sufficient room at the northeast corner but not at the southeast corner. The photo below shows the farm equipment crossing the easement.
