**INDEPENDENT CONSULTANT INSPECTION  
MAIN COOLING LAKE DAM,  
WEST ASH POND DAM AND AFTERBAY DAM  
ROXBORO ELECTRIC PLANT  
PERSON COUNTY, NORTH CAROLINA**

**PROGRESS ENERGY CAROLINAS**  
Raleigh, North Carolina

**MACTEC ENGINEERING AND CONSULTING, INC.**  
Raleigh, North Carolina

December 29, 2008

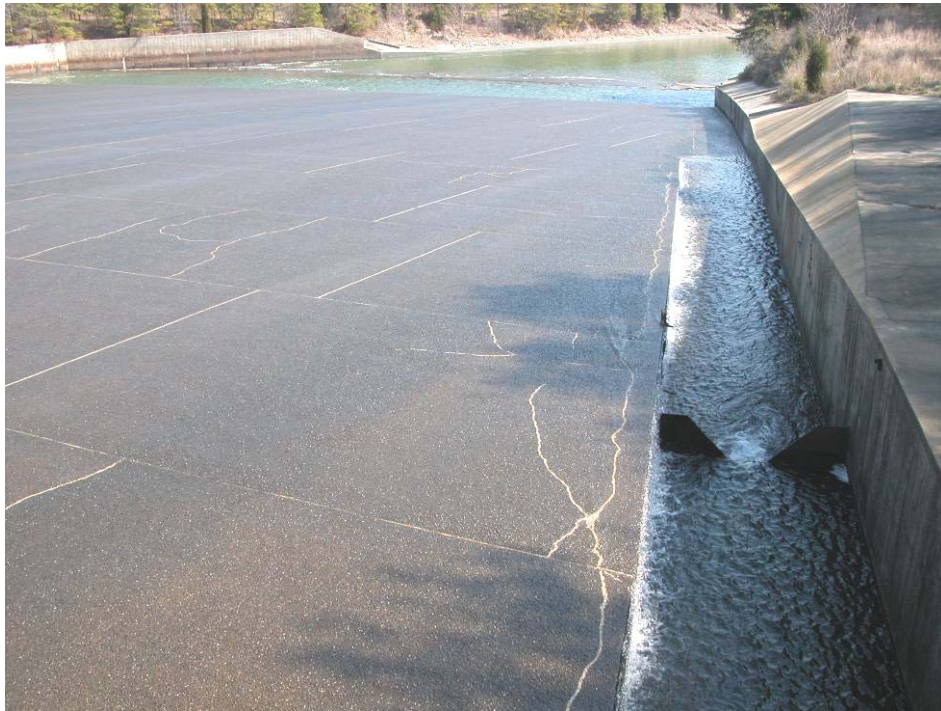
8. Main Dam – Primary spillway looking east toward drop structure. Note smooth flow pattern.

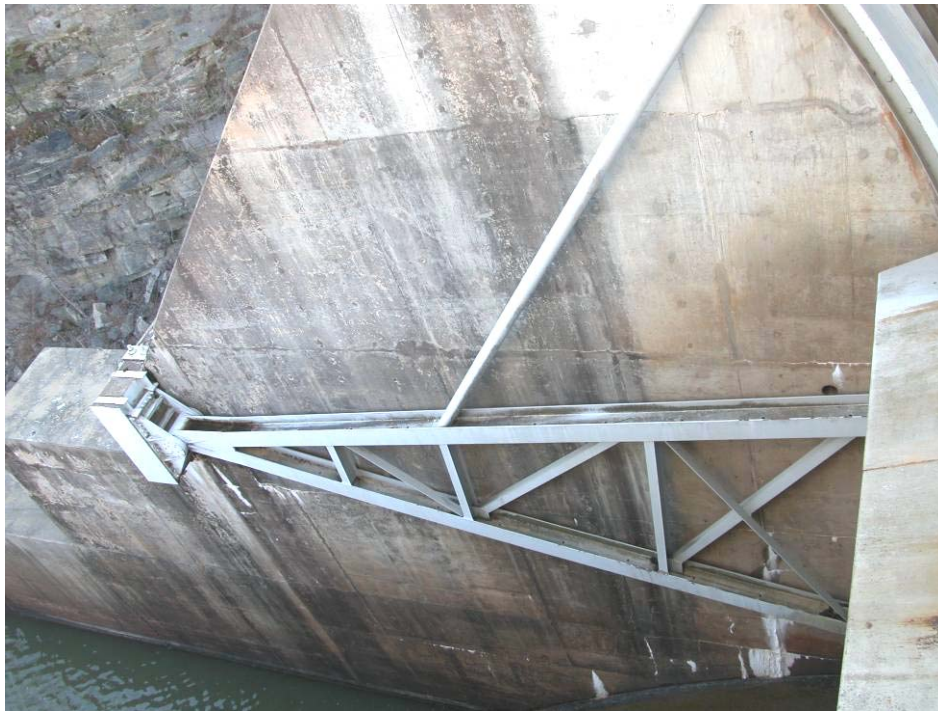
50. Afterbay Dam – East side Pier 5.

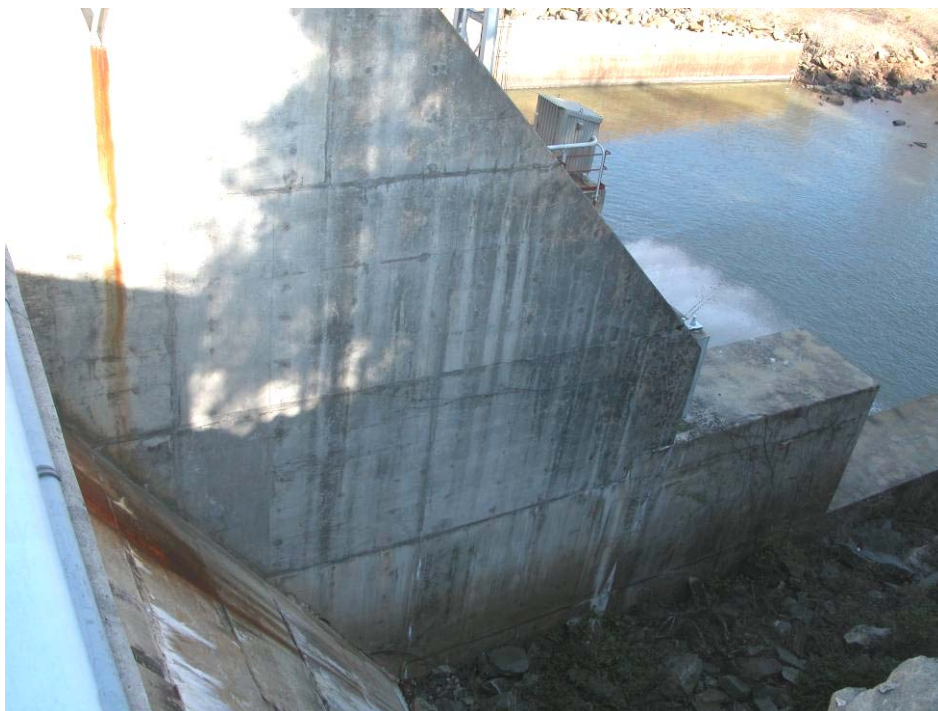
51. Afterbay Dam – West side Pier 5.
