**Green River Watershed Assessment
Isothermal Planning and Development
Commission**

September 30, 2013

Prepared for
Isothermal Planning and Development Commission
111 West Court Street
Rutherfordton County, North Carolina 28139
Project Number 2354.03

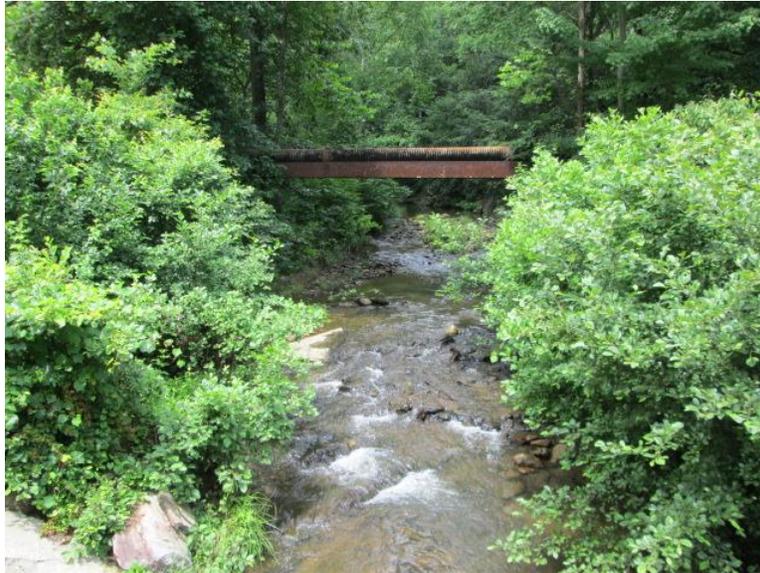
Photograph 7: View at Site 29 at road crossing facing upstream on Brights Creek just outside the Bright Creek Golf Development.

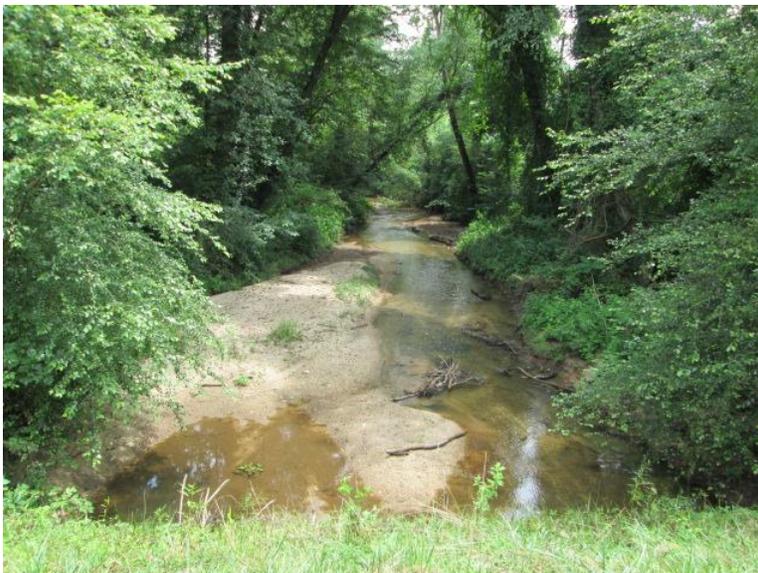
Photograph 9: View at site 21 at Palmer Road Bridge facing downstream onto Brights Creek. This reach of Brights Creek is close to the confluence of the Green River and appears to be overly wide and inundated with sediment.

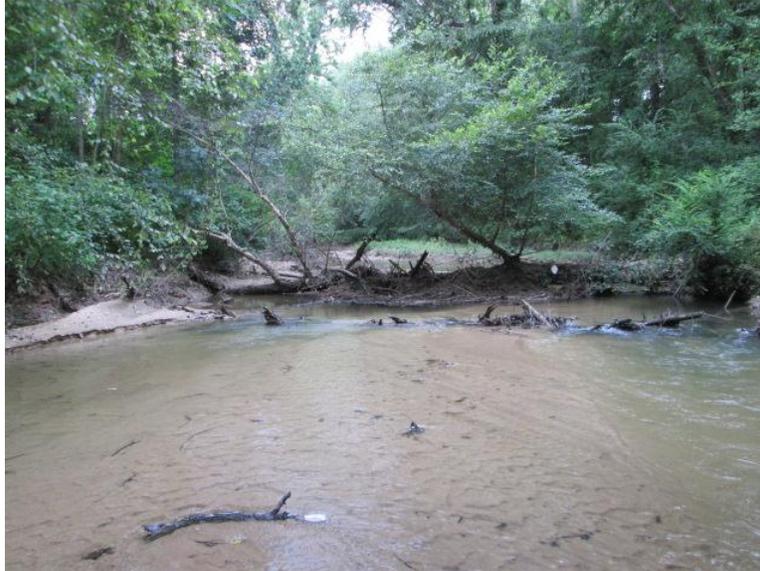
Photograph 11: View of Brights Creek confluence with the Green River.

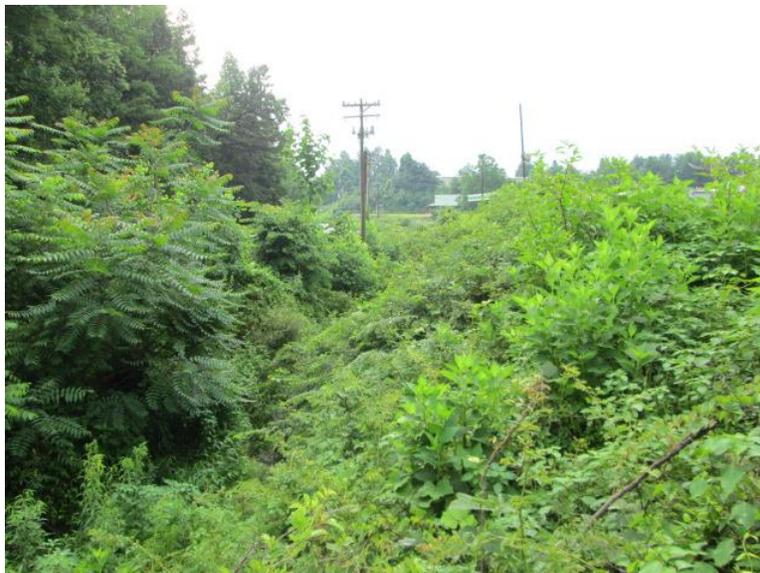
Photograph 14: Representative view at Site 8 of unnamed tributary to the Green River downstream from site 7.

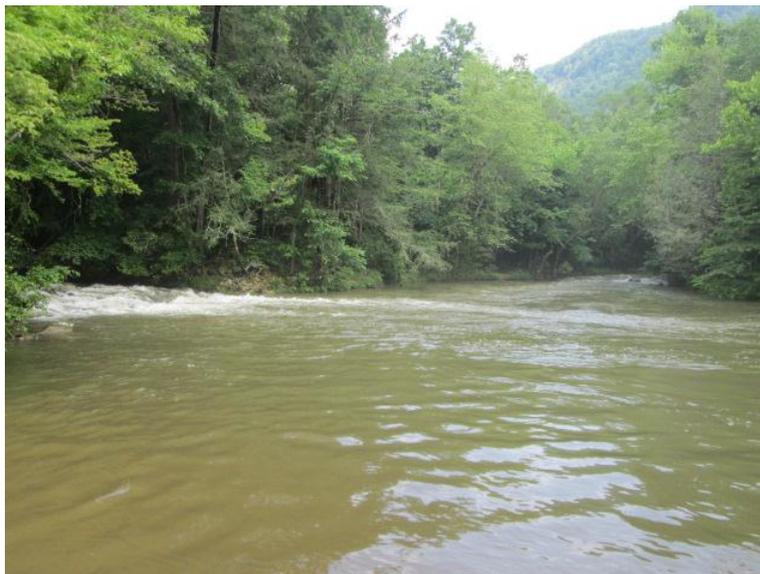
Photograph 20: View of Site 1 on the Green River facing upstream at Fish Top Access Area off Green Cove Road.

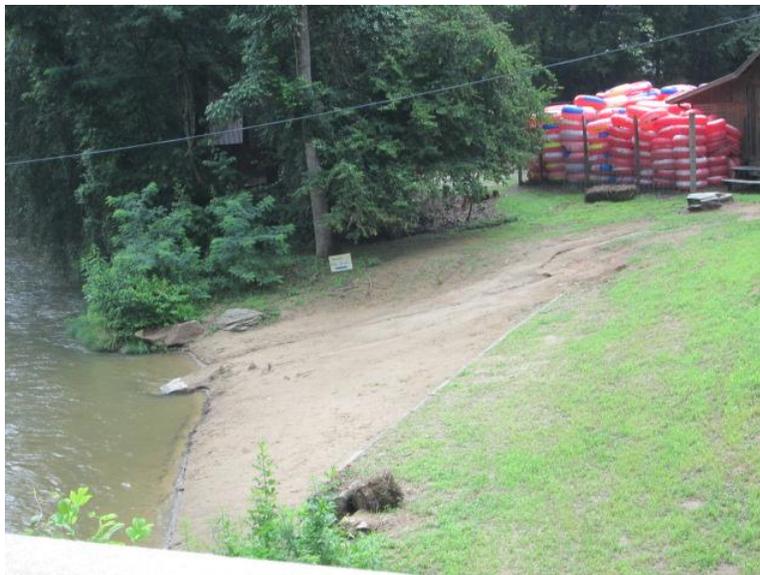
Photograph 22: View of Site 10, the Wilderness Cove Tubing Company is adjacent to the Green River.

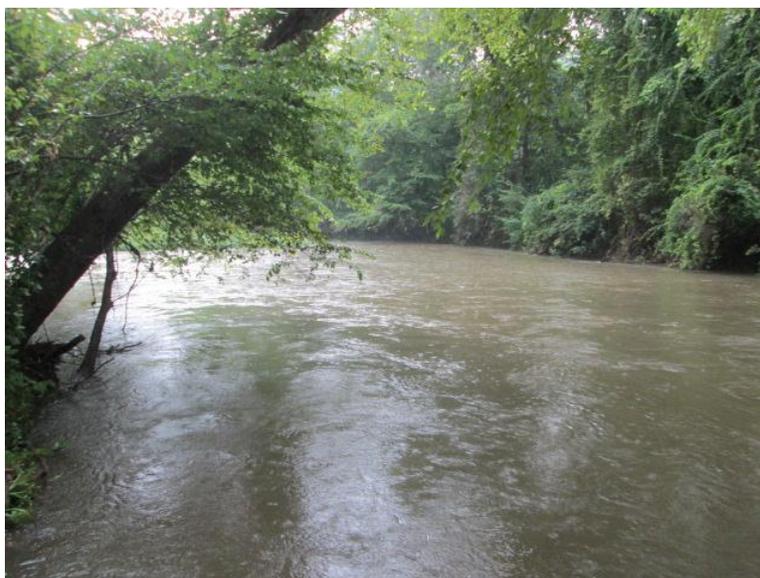
Photograph 23: Representative view of Green River facing downstream accessed from North Carolina Western Regional Access Area downstream of Site 10 at Wilderness Cove Tubing.

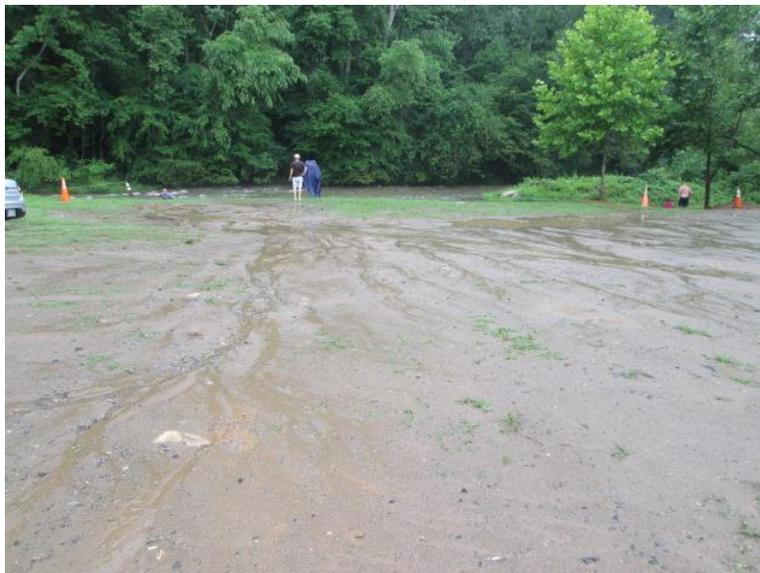
Photograph 24: View of Green River Cove Tubing parking area along the Green River near confluence with Gadd Creek at Site 2. Sedimentation from parking area discharges directly to the Green River.

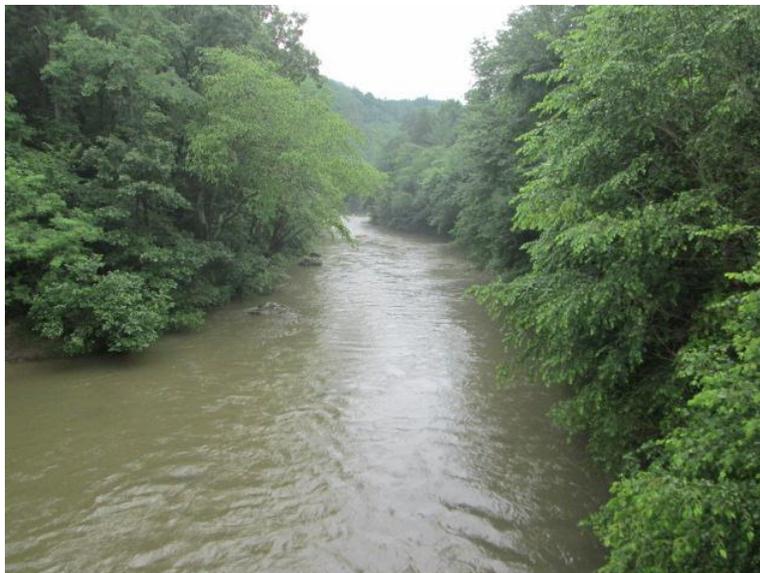
Photograph 28: View facing upstream on the Green River at Site 11 Green River.

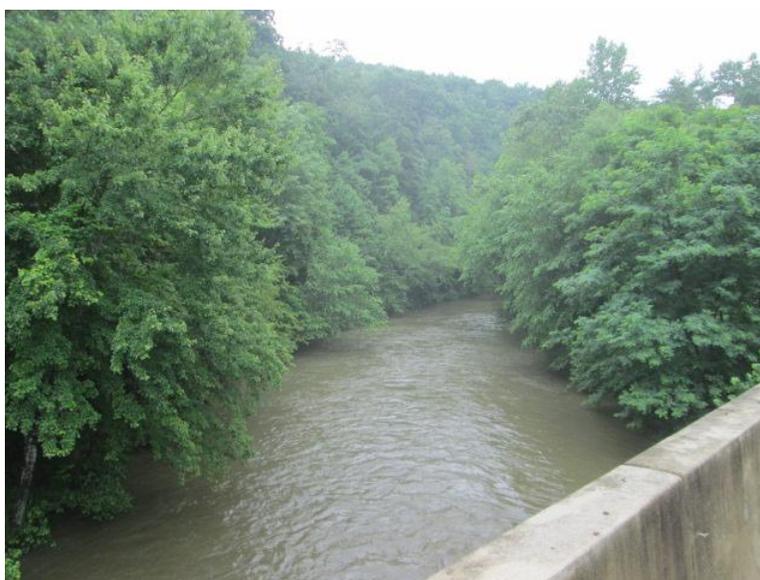
Photograph 29: View facing downstream on the Green River at Site 11 Green River.

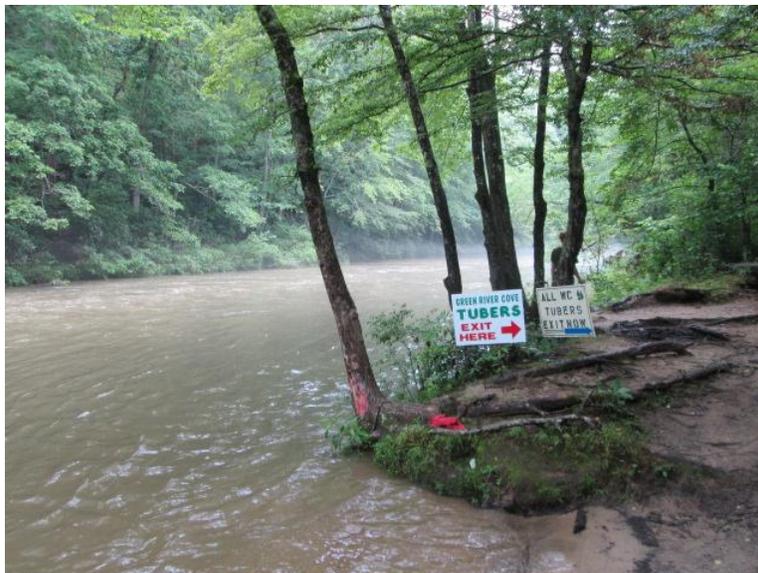
Photograph 30: View of exit point for tubers; the riparian vegetation appeared in good condition.

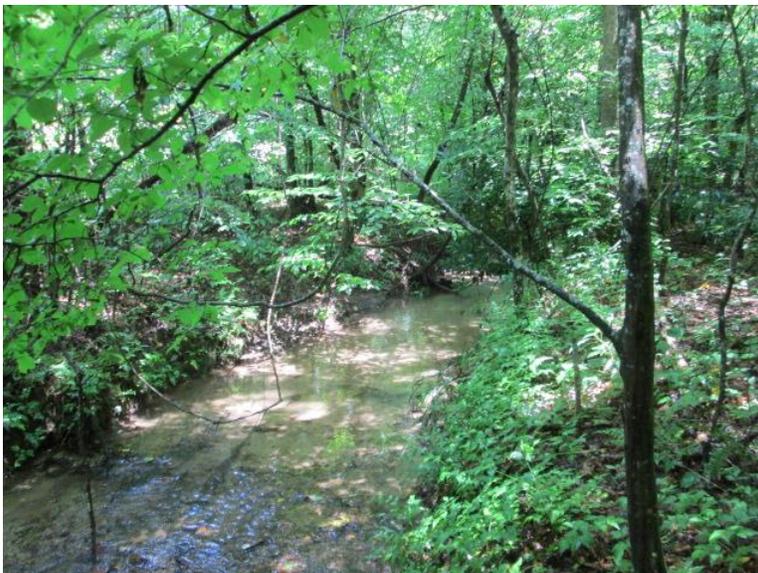
Photograph 32: View of stable tributary that flows under Green Cove Road.

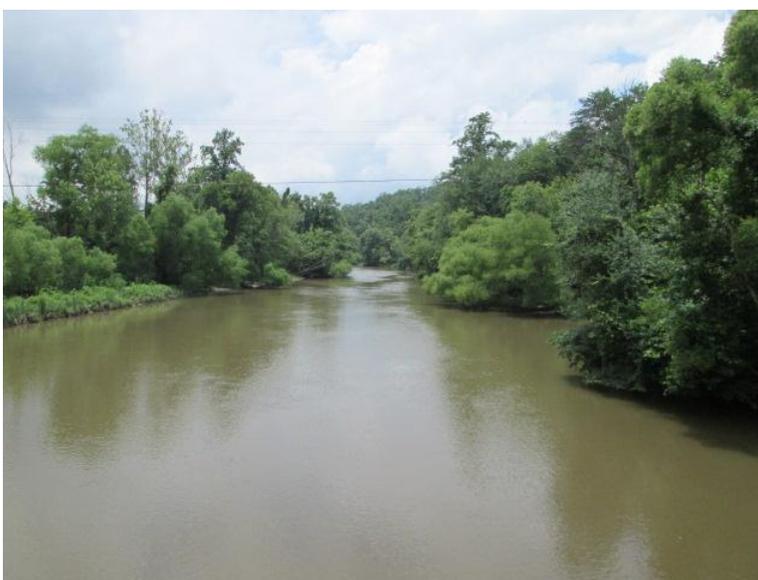
Photograph 33: View from Silver Creek Road facing upstream on the Green River near the confluence to Lake Adger.

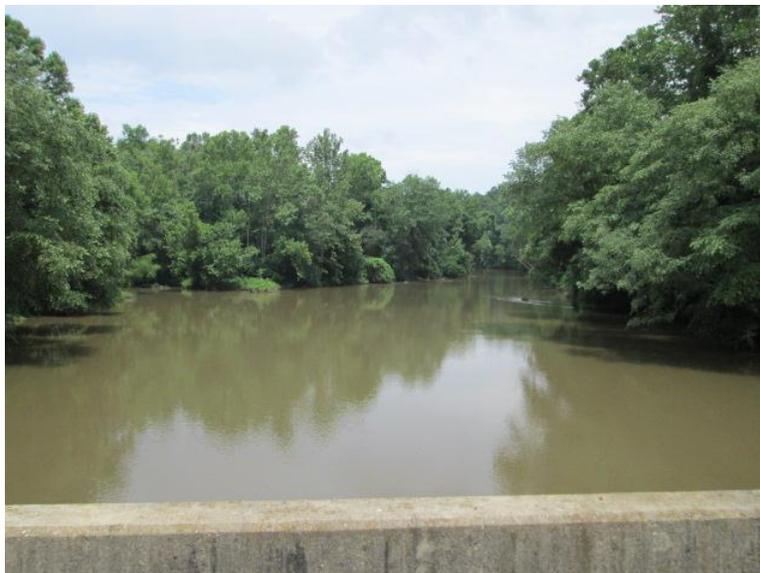
Photograph 34: View from Silver Creek Road facing downstream on the Green River.

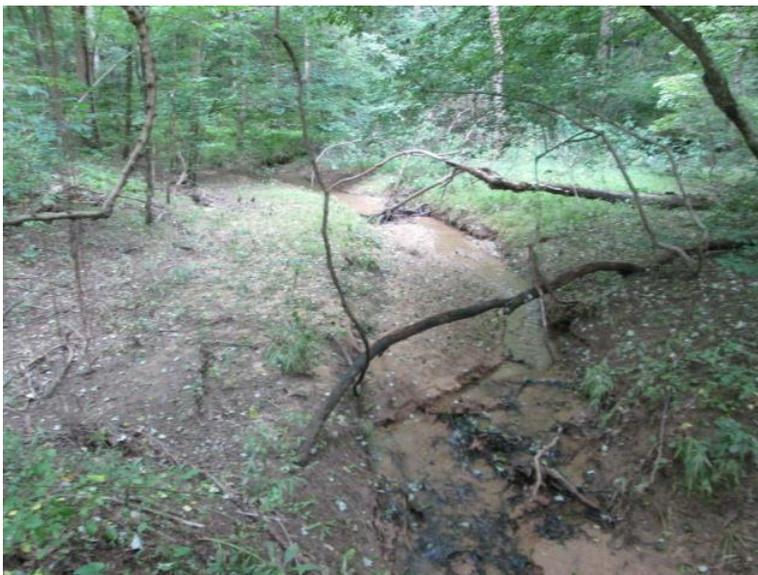
Photograph 37: View of unnamed tributary on river left of the Green River downstream of Big Rocks.

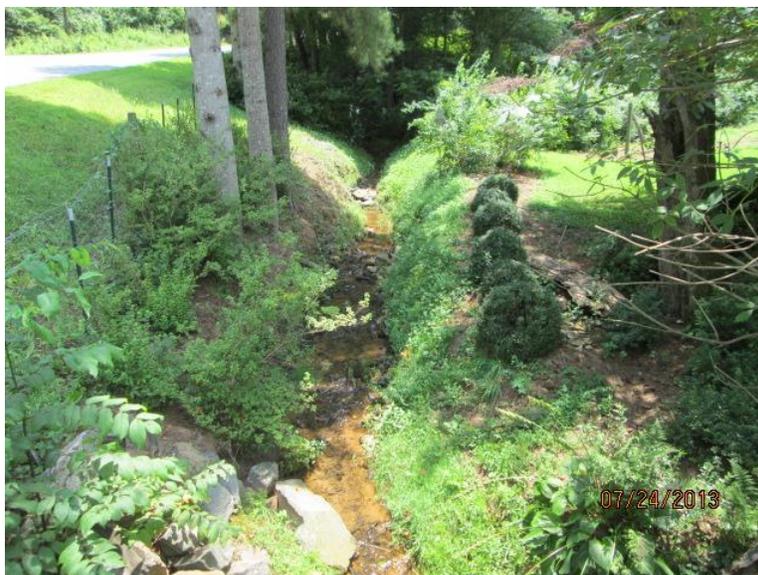
Photograph 38: View of Site 17 on a tributary to the Green River.

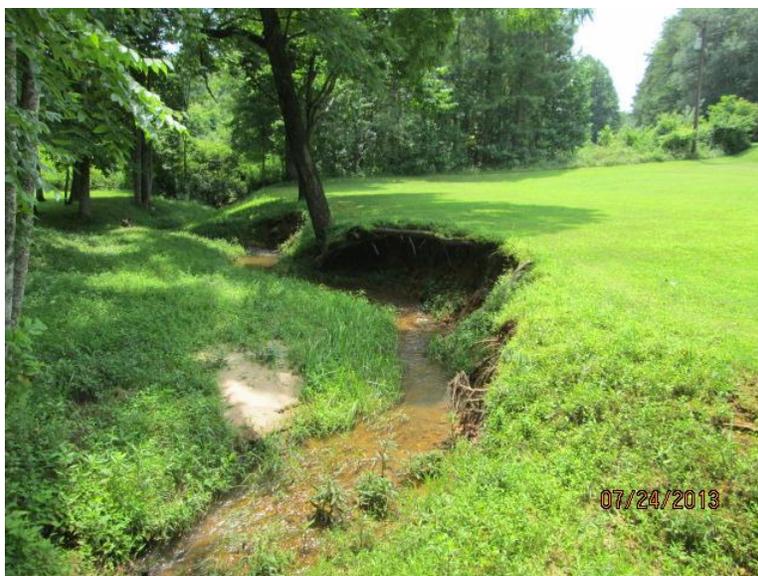
Photograph 39: View of Site 24, an unnamed tributary leading to the Green River downstream of Lake Adger. Streambanks incised and actively eroding.

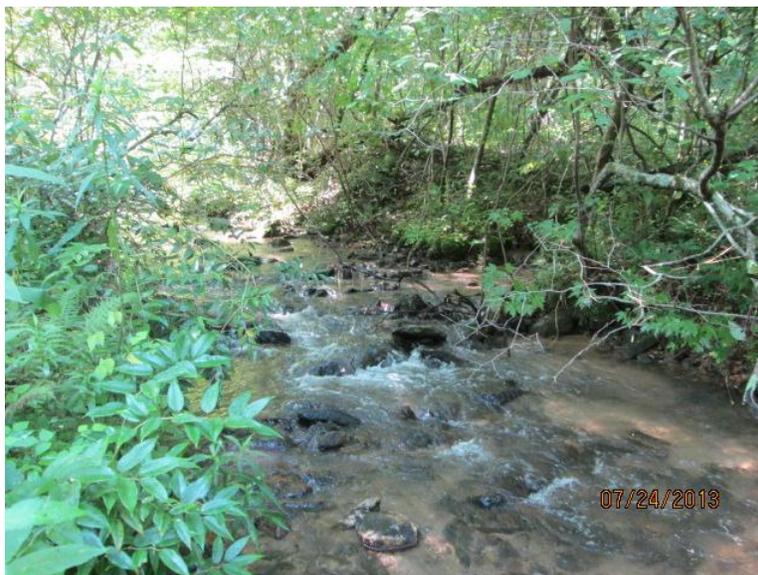
Photograph 40: View of site 20 at Ostin Creek headwaters.

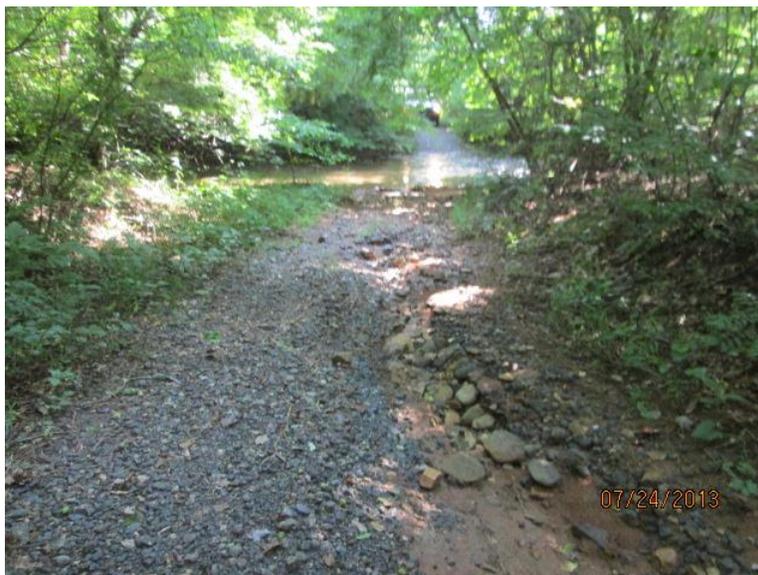
Photograph 41: View of ford crossing on site 19 on Ostin Creek. Channelized flow through crossing is a potential source of sediment.

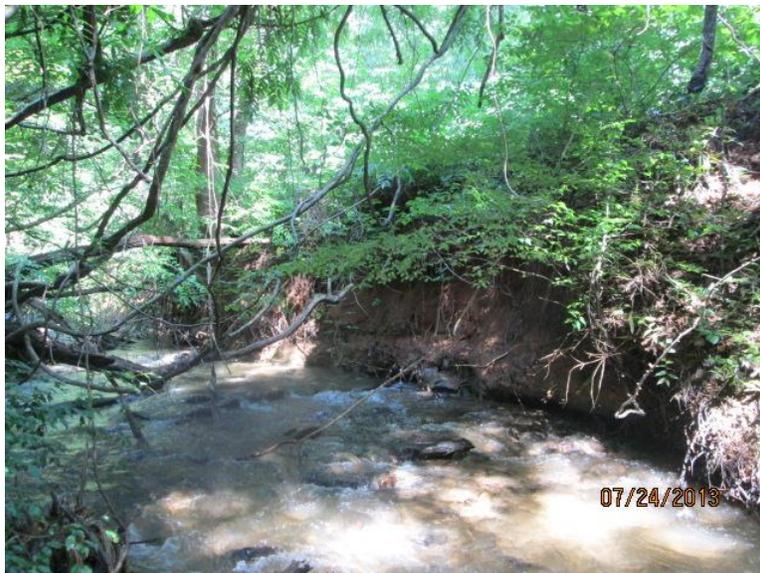
Large depositional islands were observed at the Ostin Creek entrance to Lake Adger. Stressors to Ostin Creek include exposed soil hillside erosion and a sediment-laden inline pond (Site 22), lack of riparian buffers along portions of the reach, erosion along gravel and dirt roads within the watershed, and eroding banks (Site 14 and proximate to Site 15) along the stream. Moreover, the abrupt change in channel

morphology (i.e., decrease in longitudinal slope) near the entrance to Lake Adger causes Ostin Creek to lose stream power and the ability to transport sediment. Therefore, sediment from the watershed is readily deposited near the entrance to Lake Adger.

Photograph 42: View of site 18 on Ostin Creek, with eroding banks near Holbert Cove Road upstream of Site 15.

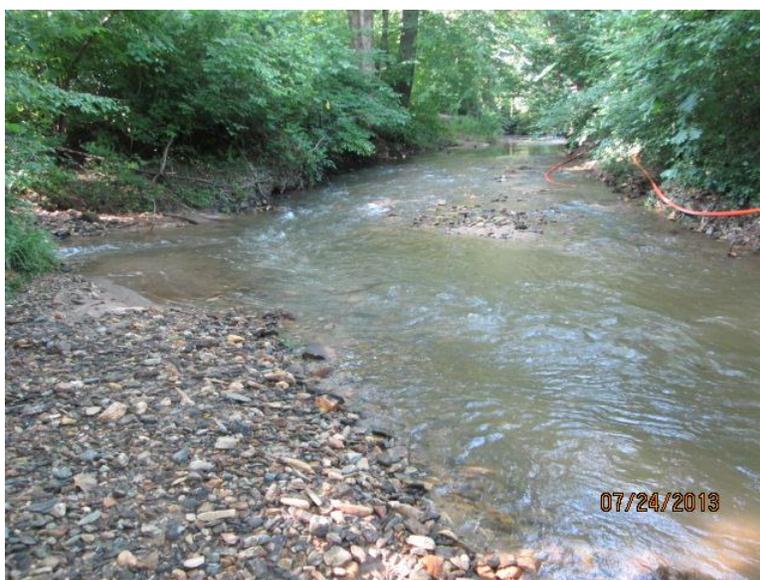
Photograph 43: View of Ostin Creek and unnamed tributary confluence just upstream of Cow Crossing Lane.

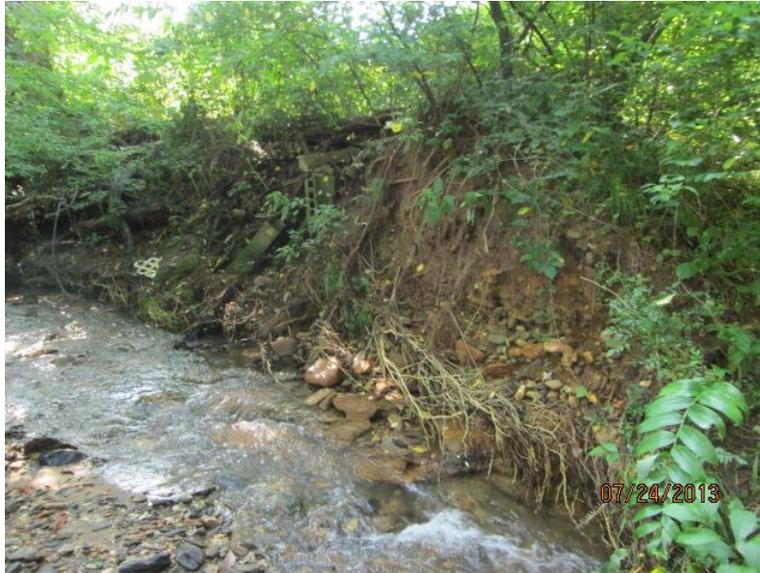
Photograph 44: View of eroding bank on tributary to Ostin Creek upstream of confluence with Ostin Creek near Cow Crossing Lane.

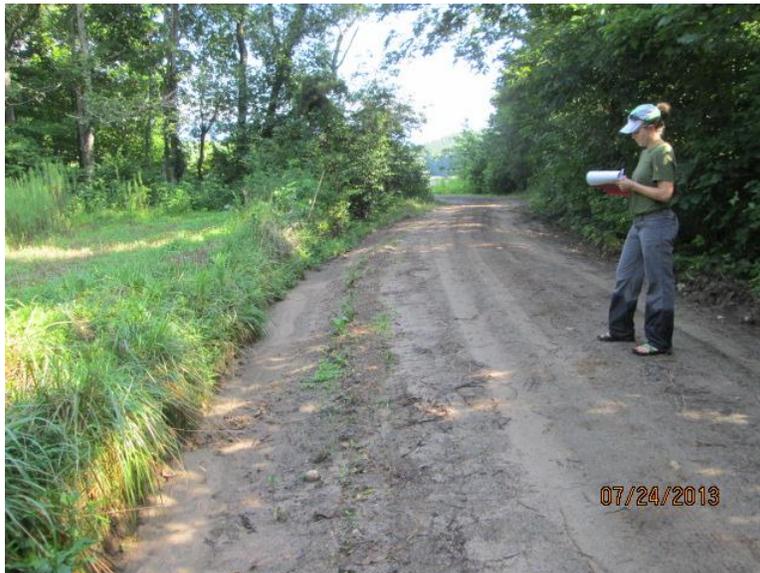
Photograph 45: View of dirt road adjacent to tributary of Ostin Creek.

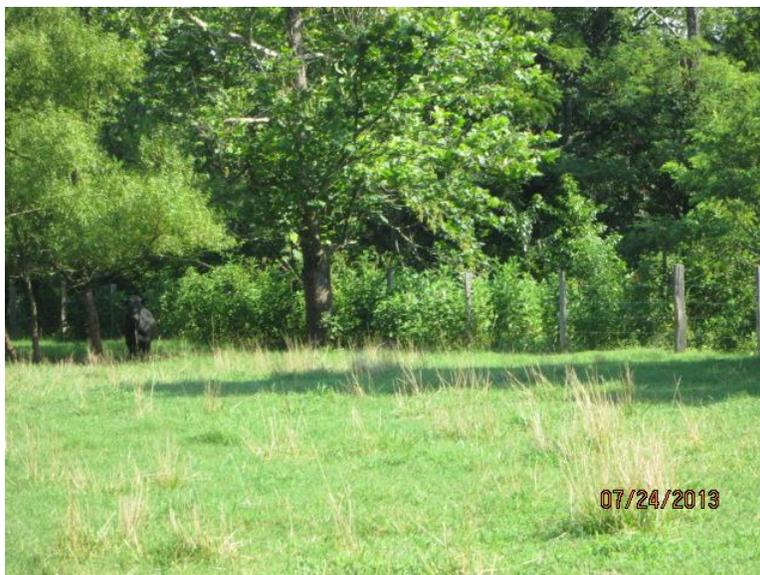
Photograph 46: Typical view of cattle exclusion fence along Ostin Creek on Site 15.

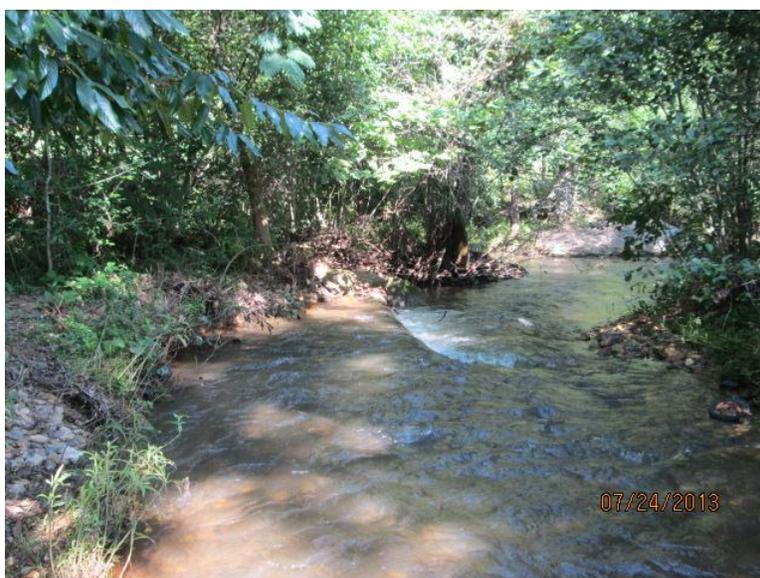
Photograph 47: Typical view of restored reach of Ostin Creek on Site 15. Log vane installed on leftbank to divert flow off leftbank.

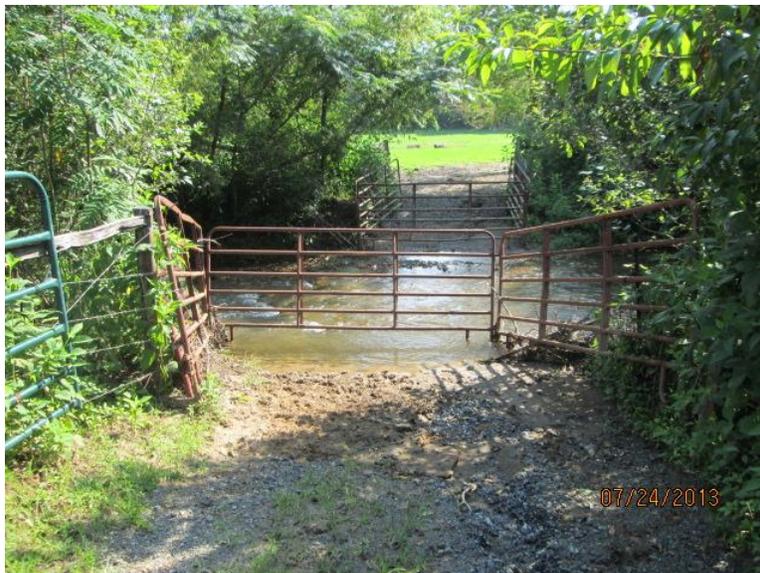
Photograph 48: View of ford crossing on Ostin Creek on Site 15.

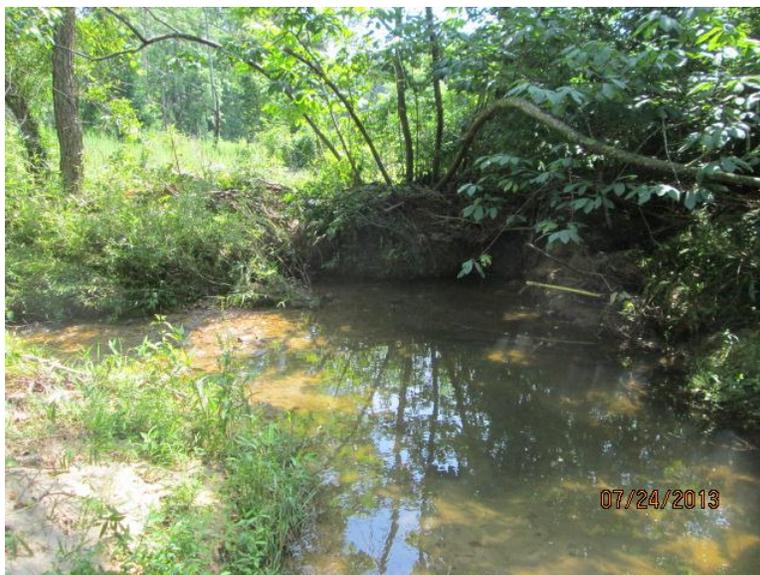
Photograph 50: View of Site 14 at Ostin Creek on Silver Creek Road.

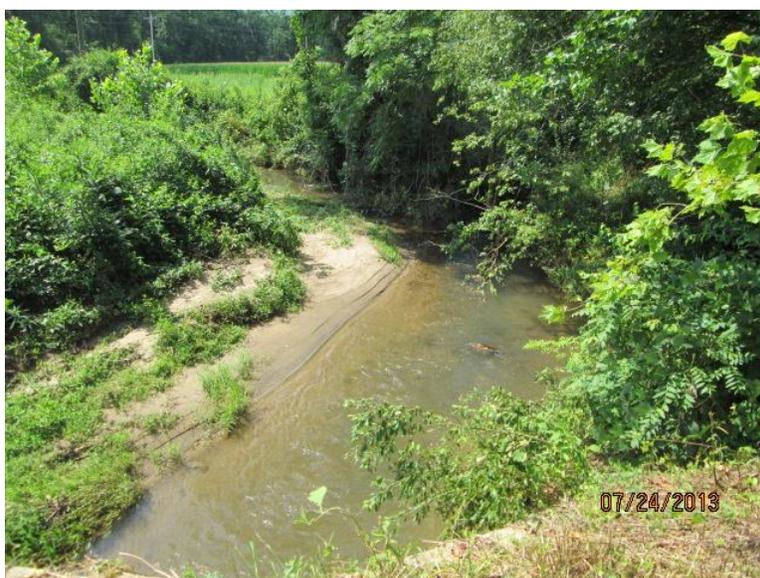
Photograph 51: View of Site 14 at Ostin Creek looking upstream from road crossing on Silver Creek Road.

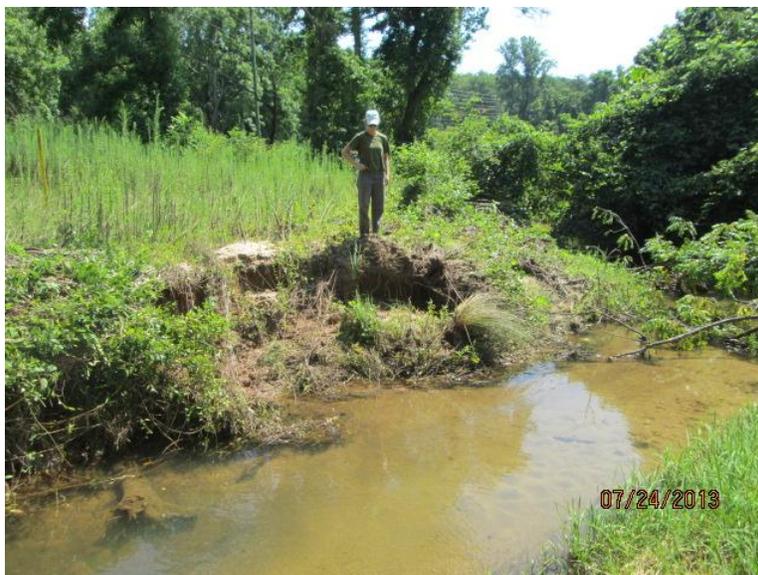
Photograph 52: View of eroding left streambank proximate to Site 14 at Ostin Creek.

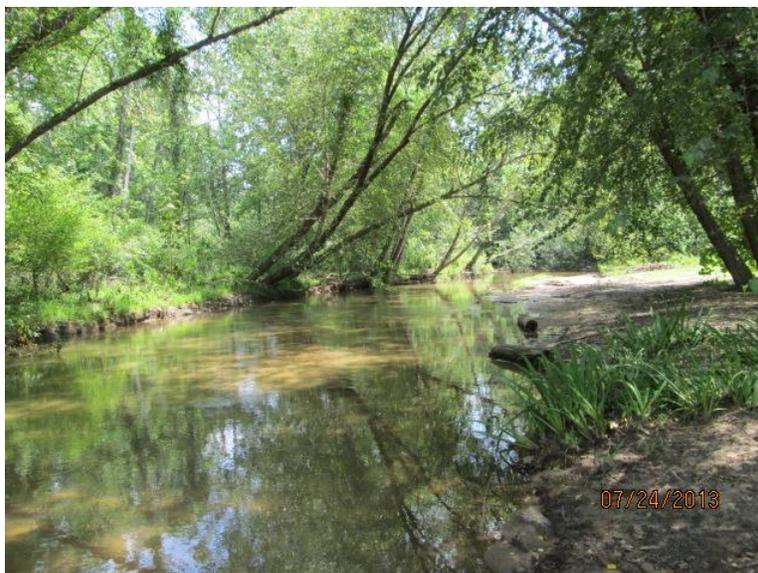
Photograph 56: View of Site 13 on Ostin Creek looking downstream from the covered bridge on the Lake Adger Development.

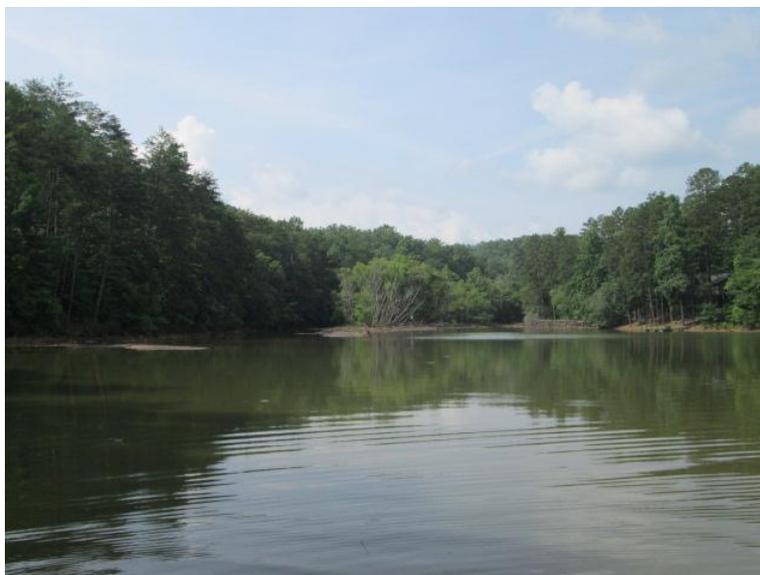
Photograph 58: View of where Ostin Creek enters Ostin Cove on Lake Adger.

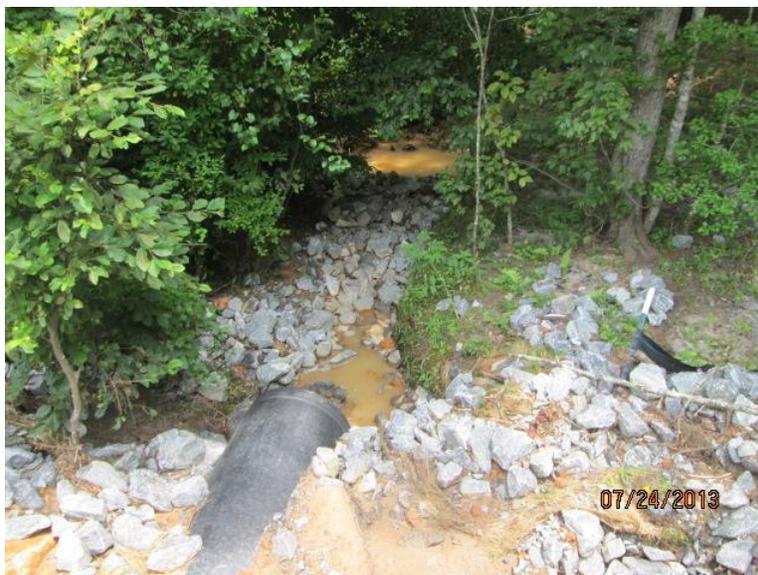
Photograph 60: View of discharge from pond at Site 22. The banks appear to be eroding, and the rip-rap also appears to be unstable.

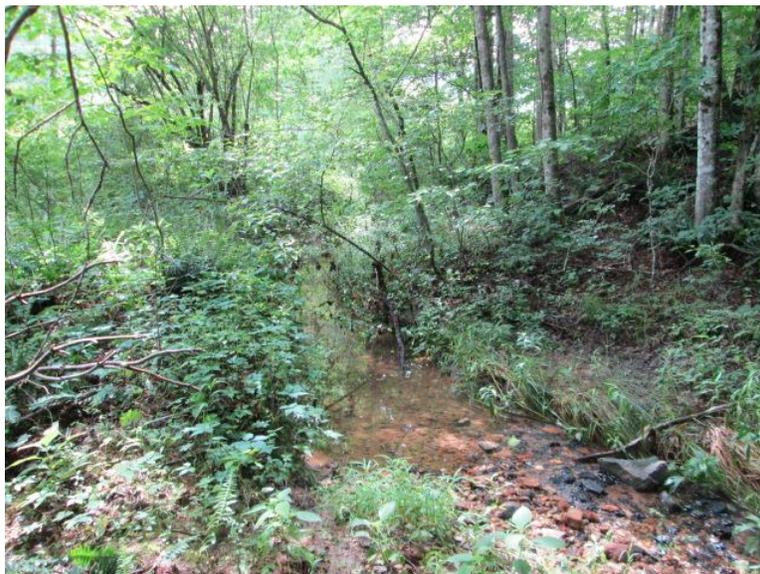
Photograph 62: View of Panther Creek at Site 6.

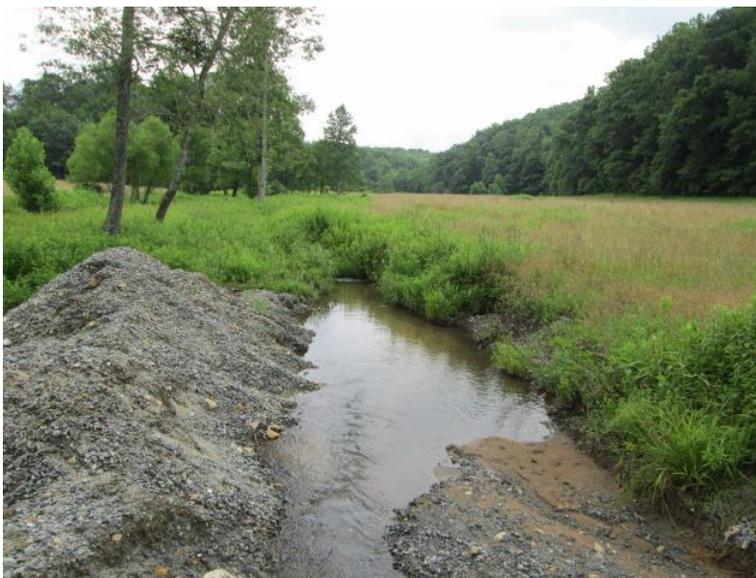
Photograph 66: View at site 26 facing downstream on Rash Creek. The gravel pile in the foreground is actively eroding into the stream, although further downstream the channel appears to be fairly stable.

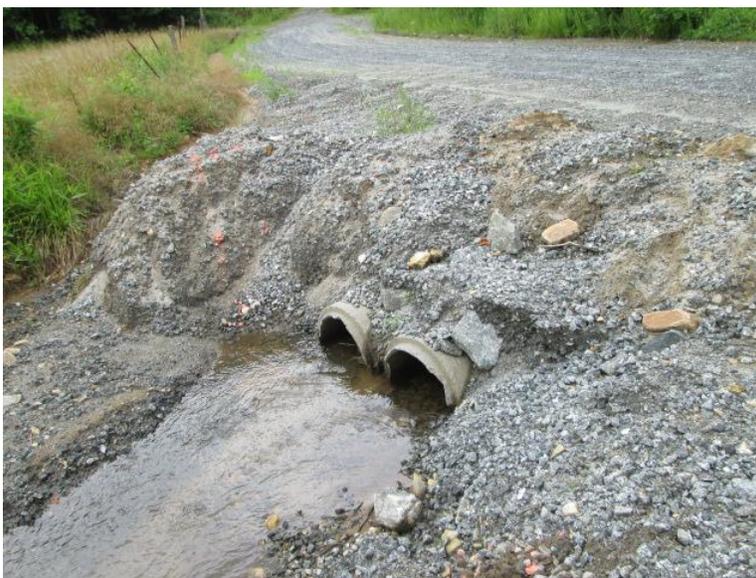
Photograph 67: View of culverts at site 26 leading to the Rash Creek. A third culvert is buried beneath the gravel.

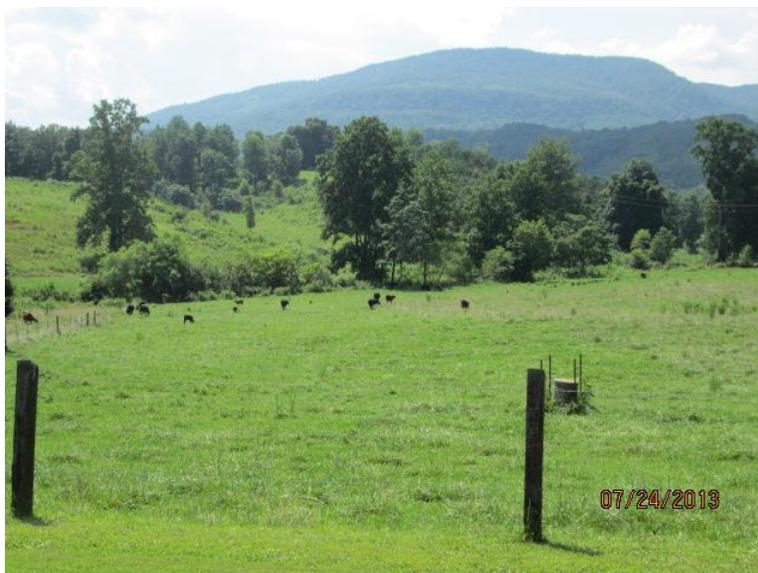
Photograph 70: View of cattle farm adjacent to Site 12 and Rotten Creek. Limited access during site visit.

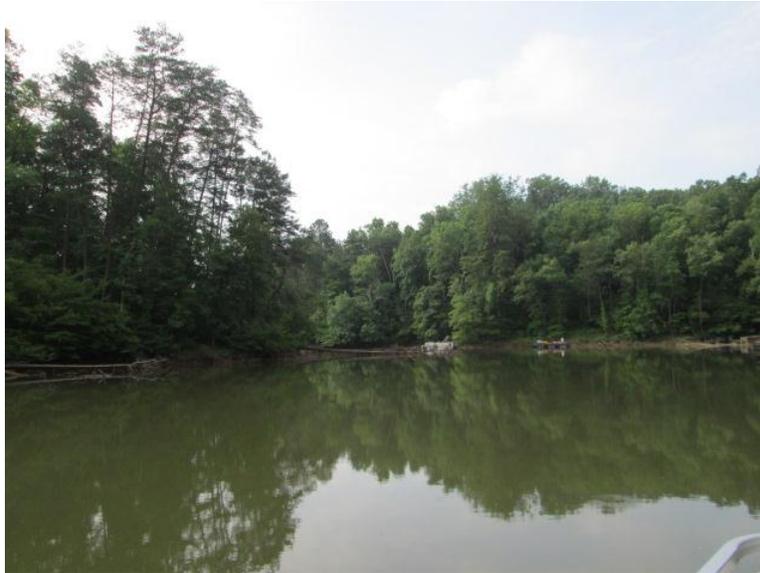
Photograph 76: View of Silver Creek entrance to South Cove on Lake Adger.

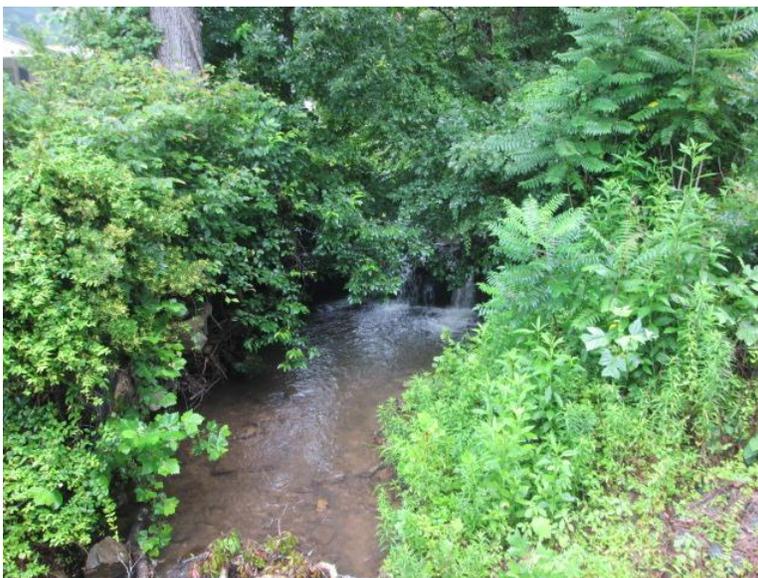
Photograph 77: View of Gadd Creek at Site 2 at confluence to Green River at Green River Cove Tubing facing upstream.

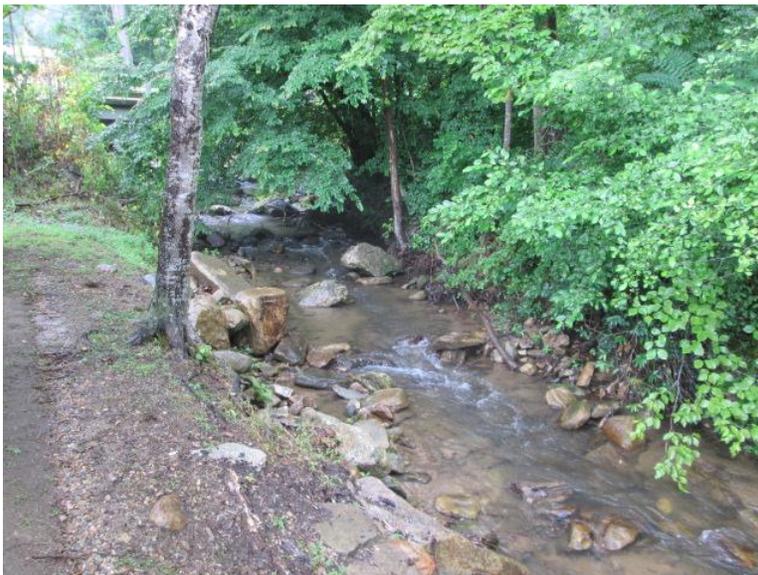
Photograph 78: View of Gadd Creek at Site 2 at confluence to Green River at Green River Cove Tubing facing downstream.

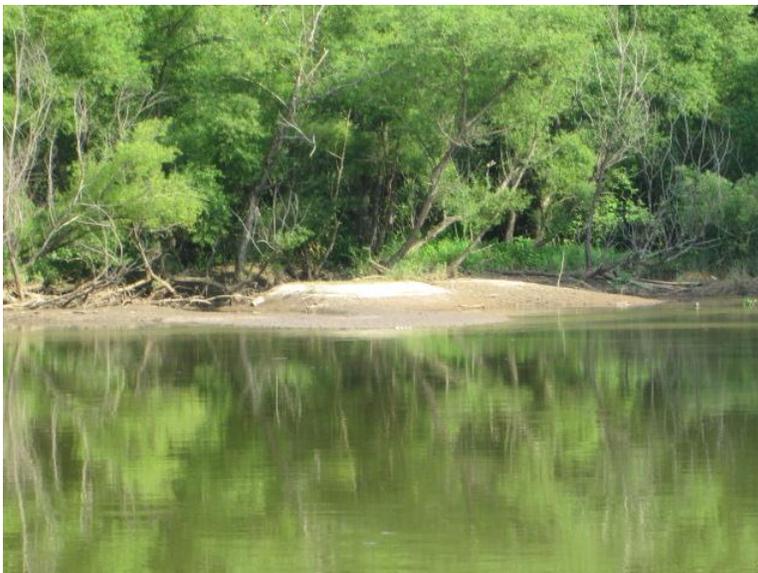
Photograph 81: View of Panther Creek entrance to Marina Cove on Lake Adger.

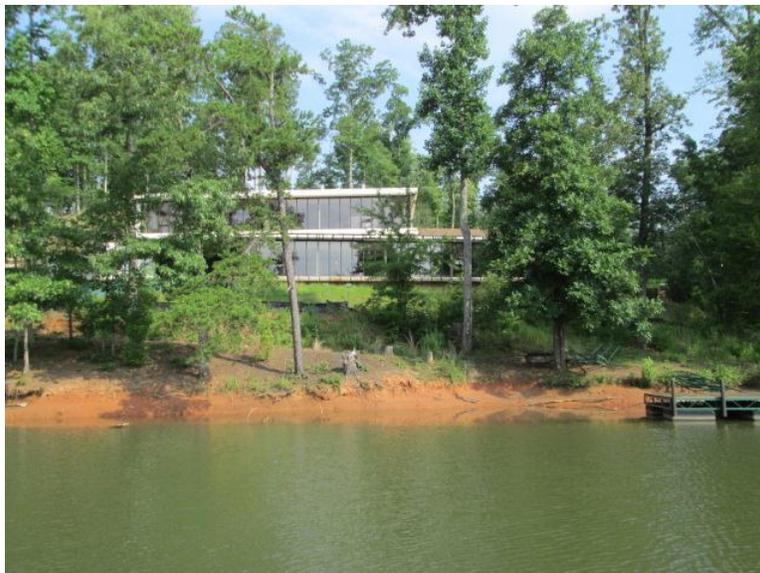
Photograph 83: View of active construction site on Lake Adger.

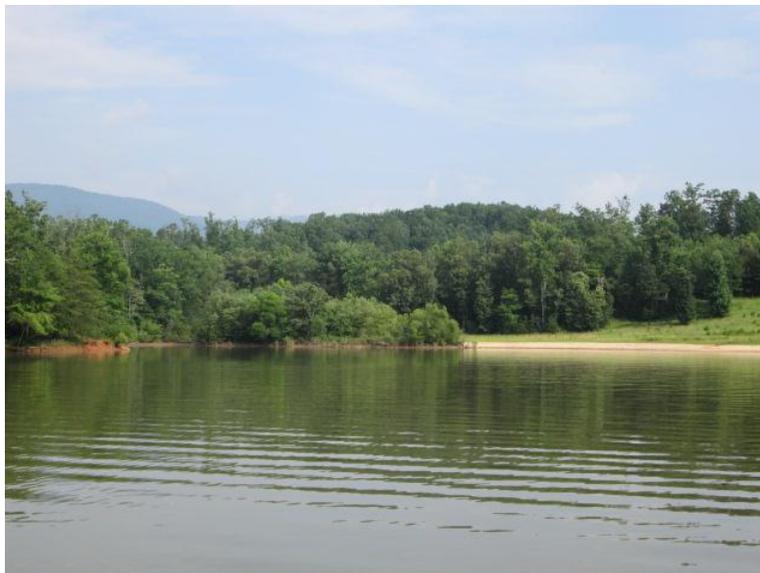
Photograph 85: View of Rotten Creek entrance to Jackson Cove on Lake Adger.

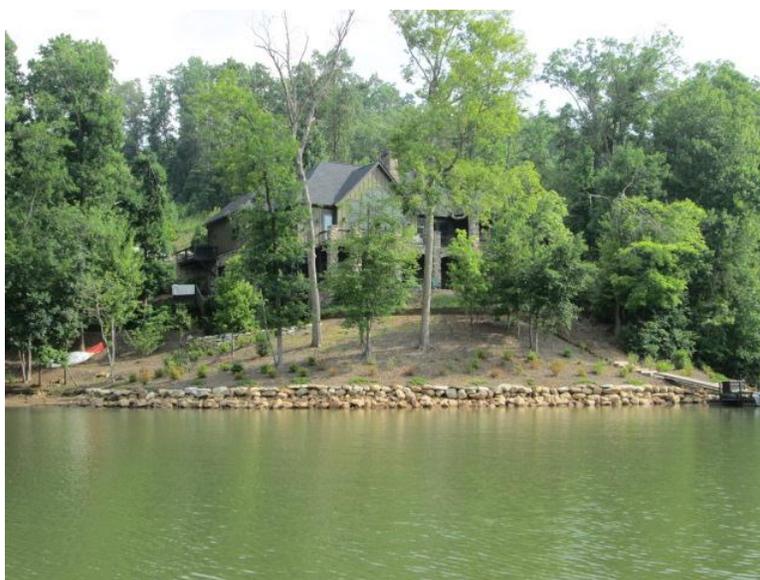
Photograph 86: View of completed shoreline stabilization on Lake Adger.

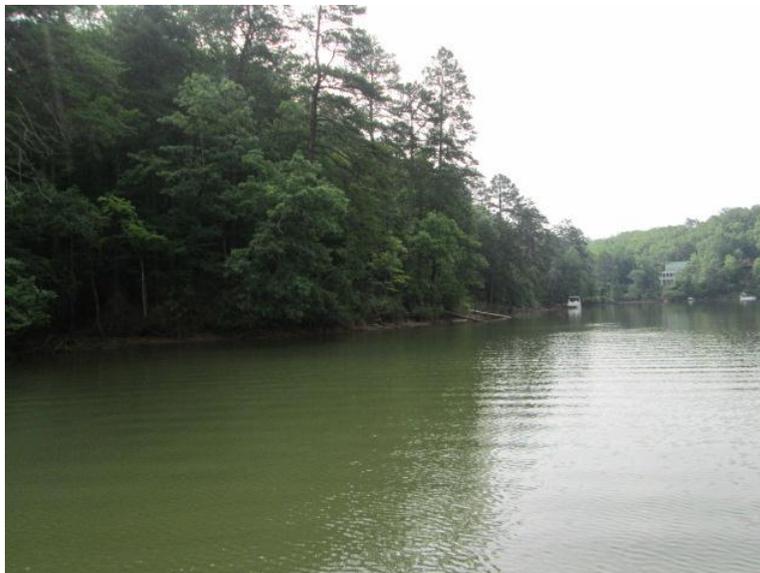
Photograph 87: Typical view of stable shoreline on Lake Adger.

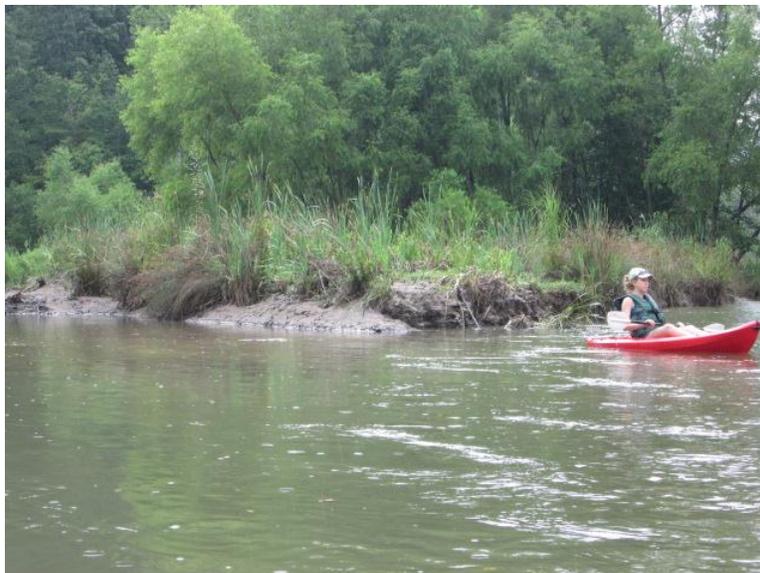
Photograph 89: View of sediment accumulation at the mouth of the Green River to Lake Adger.

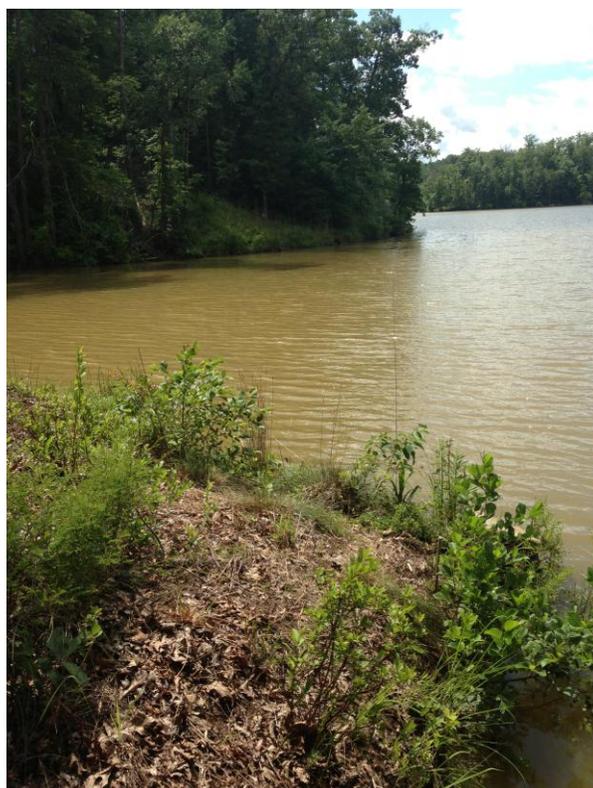
Photograph 90: Typical view of Lake Adger observed from the streambank.

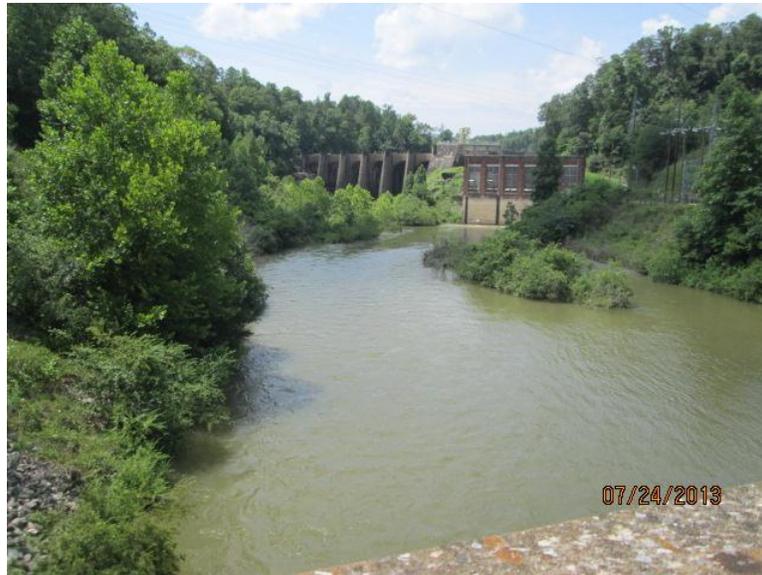
Photograph 95: View of Lake Adger dam facing upstream.

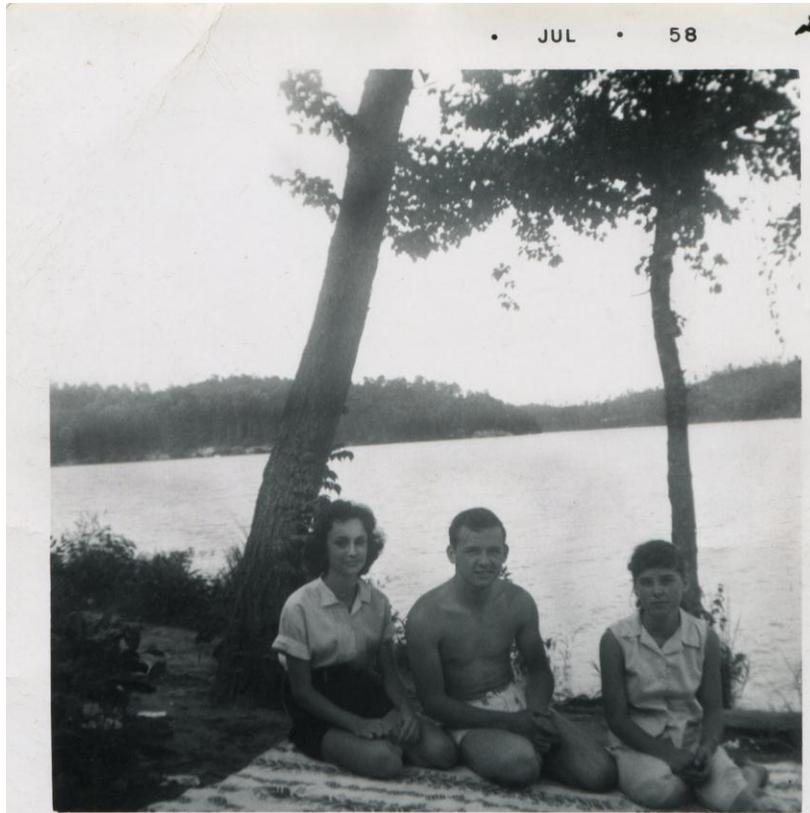
Photograph 3: View of Lake Adger near public marina and entrance of the Green River taken in 1953 (photo courtesy of Albert Cochran).
