**Green River Watershed Assessment
Isothermal Planning and Development
Commission**

September 30, 2013

Prepared for
Isothermal Planning and Development Commission
111 West Court Street
Rutherfordton County, North Carolina 28139
Project Number 2354.03

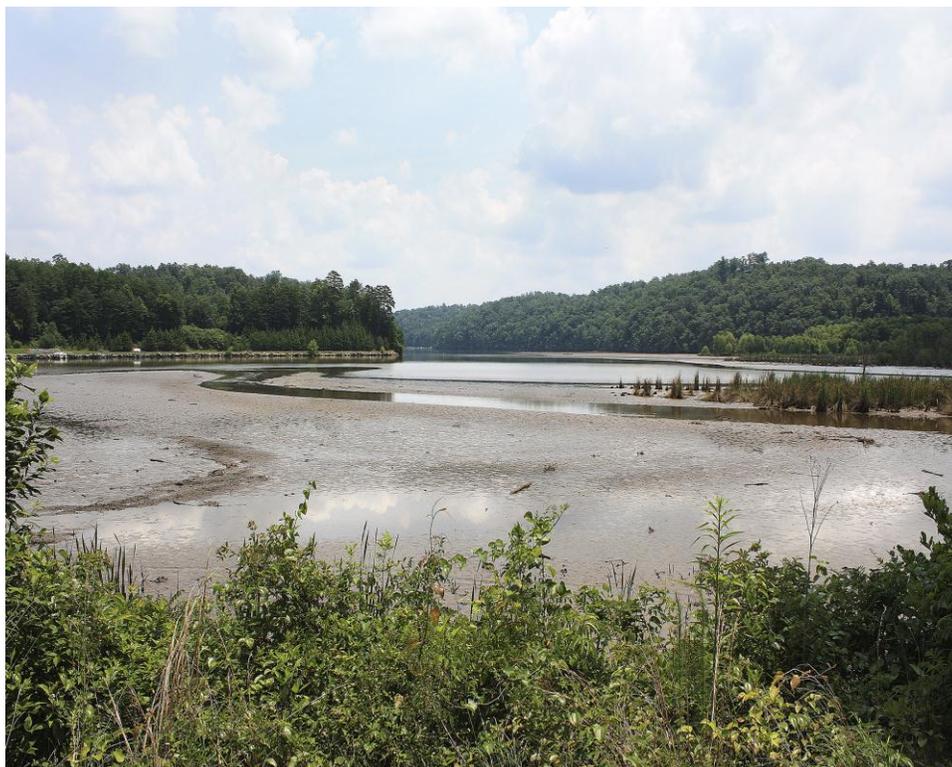
Photograph 4: Comparison view of Photograph 3 of Lake Adger near public marina and entrance of the Green River taken in 2013 (photo courtesy of Sky Conard).
